General Information

Make	Toyota	Model	Vios
YOM	2024	Odo Meter Reading	31,382
Registration No.	NHS1851	Chassis No.	PA1B18F36P4231188
CC	1.3	Transmission	CVT
Fuel Type	Gas	Type of Body	Sedan
Colour	Silver

Body / Panel Condition

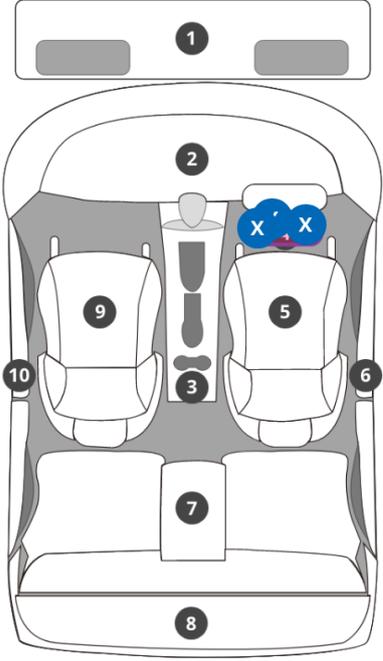
Interior Evaluation : B	Exterior Evaluation : C

<p>a : Cut, Fray d : Loose, Deformed k : Animal Hair s : Smell t : Cigarette Burns x : Defective y : Stain</p>

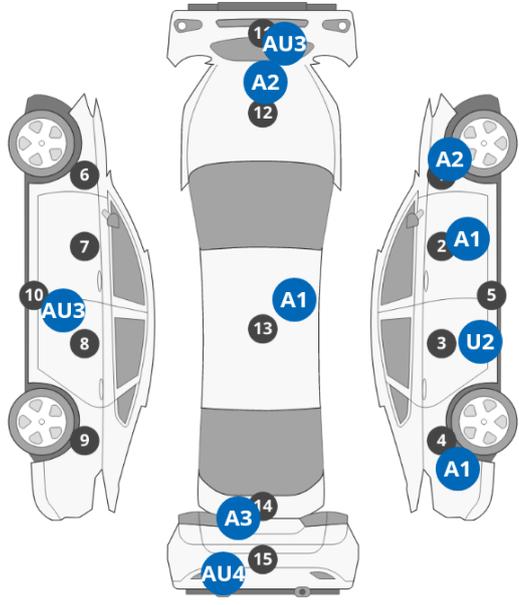
<p>A : Scratch AU : Scratch & Dent B : Modified C : Corrosion G : Stone chip P : Faded S : Rust SC : Rust & Corrosion U : Dent X : Defective Y : Crack, Gap</p>
<p>Remarks (L) Front Floor Mat - Missing - Yes / (R) Front Floor Mat - Missing - Yes / Mat Other - Missing - Yes</p>	<p>Remarks Rear Bumper, Lamps, Panels - Scratch & Dent - Large / Trunk Hood, Rear Gate - Scratch - Medium / (L) Rear Door, Molding - Scratch & Dent - Medium / Front Bumper, Grille, Lamps - Scratch & Dent - Medium / (R) Rear Door, Molding - Dent - Small / (R) Rear Fender, Molding - Scratch - Minimal / (R) Front Door, Molding - Scratch - Minimal / (R) Front Fender, Molding - Scratch - Small / Roof - Scratch - Minimal / Bonnet, Headlight - Scratch - Small</p>
