General Information

Make	Toyota	Model	Vios
YOM	2024	Odo Meter Reading	40,435
Registration No.	NHM6830	Chassis No.	PA1B18F30R4242835
CC	1.3	Transmission	CVT
Fuel Type	Gas	Type of Body	Sedan
Colour	Green

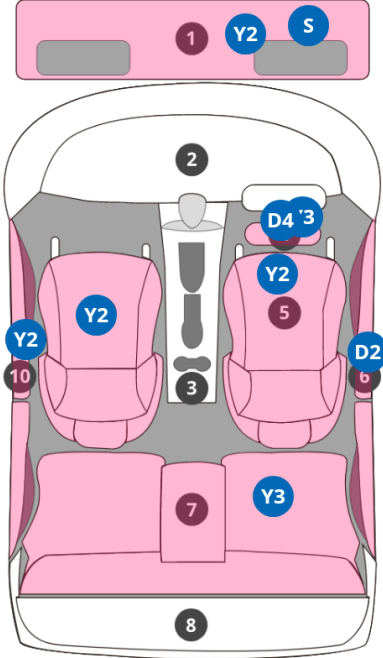
Interior Evaluation : C	Exterior Evaluation : C

<p>a : Cut, Fray d : Loose, Deformed k : Animal Hair s : Smell t : Cigarette Burns x : Defective y : Stain</p>

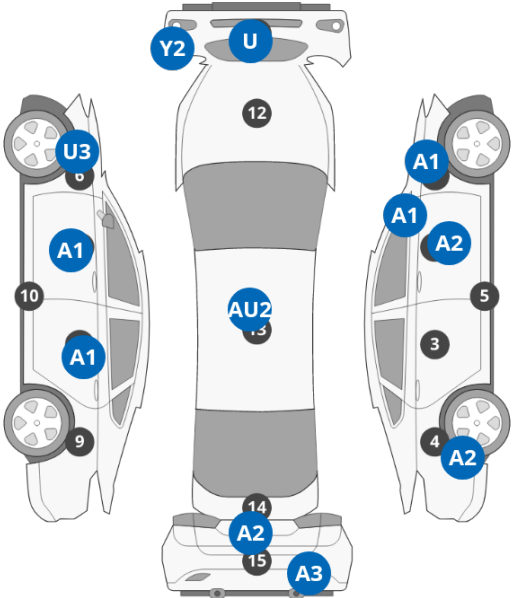
<p>A : Scratch AU : Scratch & Dent B : Modified C : Corrosion G : Stone chip P : Faded S : Rust SC : Rust & Corrosion U : Dent X : Defective Y : Crack, Gap</p>
<p>Remarks Rear Seat - Grime - Medium / (R) Front Seat - Grime - Small / (L) Front Seat - Grime - Small / (L) Front Floor Mat - Grime - Medium / (R) Front Trim - Worked - Small / (R) Front Floor Mat - Worked - Large / (L) Front Trim - Grime - Small / Ceiling - Grime - Small / Overall Interior - Smell - Yes</p>	<p>Remarks (L) Front Fender, Molding - Dent - Medium / (L) Front Door, Molding - Scratch - Minimal / (L) Rear Door, Molding - Scratch - Minimal / Member (Bolted) - Dent - Yes / (R) Rear Fender, Molding - Scratch - Small / Rear Bumper, Lamps, Panels - Scratch - Medium / Trunk Hood, Rear Gate - Scratch - Small / Roof - Scratch & Dent - Small / Front Bumper, Grille, Lamps - Crack, Gap - Small / (R) Front Fender, Molding - Scratch - Minimal / (R) Front Door, Molding - Scratch - Small / (R) Mirror - Scratch - Minimal</p>
