General Information

Make	Toyota	Model	Vios
YOM	2025	Odo Meter Reading	10,250
Registration No.	CCG1570	Chassis No.	PA1B18F35R4279039
CC	1.3	Transmission	CVT
Fuel Type	Gas	Type of Body	Sedan
Colour	Silver

Body / Panel Condition

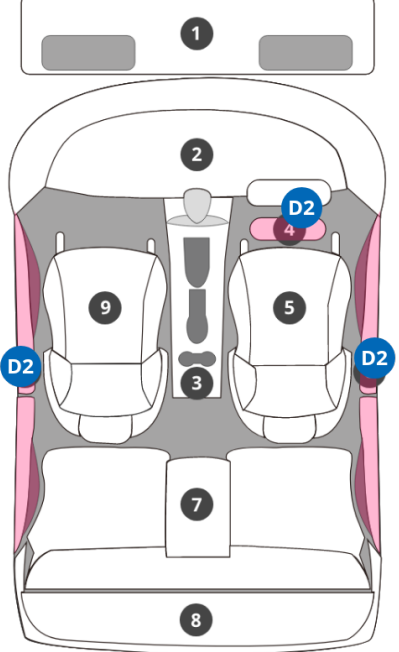
Interior Evaluation : A	Exterior Evaluation : B

<p>a : Cut, Fray d : Loose, Deformed k : Animal Hair s : Smell t : Cigarette Burns x : Defective y : Stain</p>

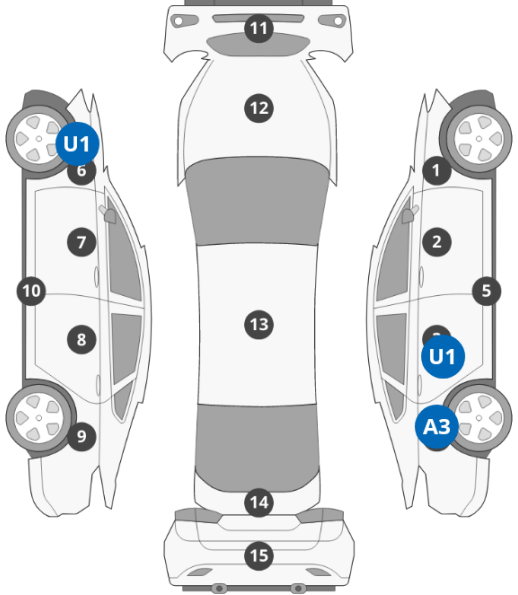
<p>A : Scratch AU : Scratch & Dent B : Modified C : Corrosion G : Stone chip P : Faded S : Rust SC : Rust & Corrosion U : Dent X : Defective Y : Crack, Gap</p>
<p>Remarks (L) Front Floor Mat - Worked - Small / (L) Front Trim - Worked - Small / (R) Front Trim - Worked - Small</p>	<p>Remarks (L) Front Fender, Molding - Dent - Minimal / (R) Rear Fender, Molding - Scratch - Medium / (R) Rear Door, Molding - Dent - Minimal</p>
Frame Evaluation : A	Functional Evaluation : A
<p>Remarks Defects not found</p>	<p>Remarks Defects not found</p>

<p>Inspector Notes</p>
<p>With LTO plate and warranty booklet, No Tools and Jack and Sparetire, Scratch headlight and tail light.</p>
