General Information

Make	Toyota	Model	Innova
YOM	2025	Odo Meter Reading	17,840
Registration No.	NKI1189	Chassis No.	PA2JA8EM4R0148595
CC	2.8	Transmission	A/T
Fuel Type	Diesel	Type of Body	Wagon
Colour	Blackish Red Mica

Body / Panel Condition

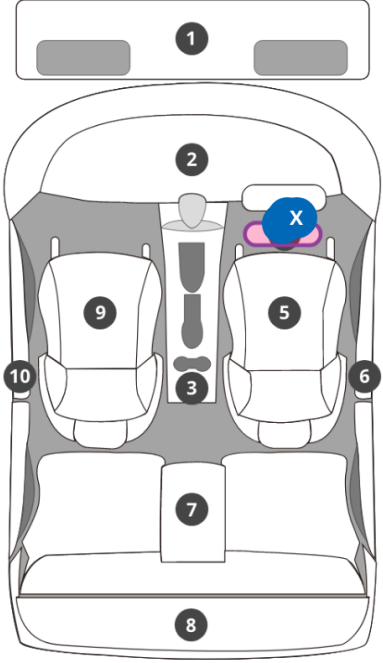
Interior Evaluation : B	Exterior Evaluation : B

<p>a : Cut, Fray d : Loose, Deformed k : Animal Hair s : Smell t : Cigarette Burns x : Defective y : Stain</p>

<p>A : Scratch AU : Scratch & Dent B : Modified C : Corrosion G : Stone chip P : Faded S : Rust SC : Rust & Corrosion U : Dent X : Defective Y : Crack, Gap</p>
Remarks (L) Front Floor Mat - Missing - Yes / (R) Front Floor Mat - Missing - Yes / Mat Other - Missing - Yes	Remarks (L) Rear Fender - Repair Traces - Yes / (L) Front Fender, Molding - Scratch - Minimal / (L) Rear Fender, Molding - Repair mark - Yes / (L) Rear Fender, Molding - Scratch - Minimal / (L) Rear Door, Molding - Scratch - Minimal / (L) Front Door, Molding - Scratch - Minimal / Bonnet, Headlight - Scratch - Minimal / Front Bumper, Grille, Lamps - Scratch - Small / (R) Front Fender, Molding - Scratch - Minimal / (R) Front Door, Molding - Scratch - Minimal / (R) Rear Door, Molding - Scratch - Small / (R) Rear Fender, Molding - Scratch - Minimal / Trunk Hood, Rear Gate - Scratch - Minimal / Roof - Scratch - Small

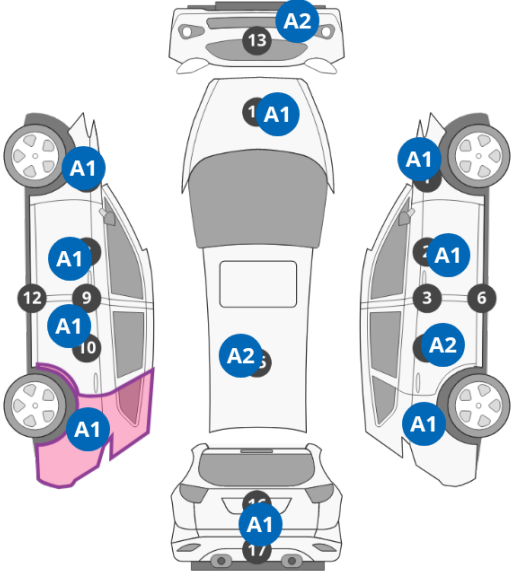
Inspector Notes
With LTO plate and Sparetire and Jack and Incomplete Tools and warranty booklet, scratch headlight and tail light, hazard button issue.
