General Information

Make	Toyota	Model	Vios
YOM	2025	Odo Meter Reading	24,938
Registration No.	NGC9713	Chassis No.	PA1B18F38RR4270898
CC	1.3	Transmission	CVT
Fuel Type	Gas	Type of Body	Sedan
Colour	Silver

Body / Panel Condition

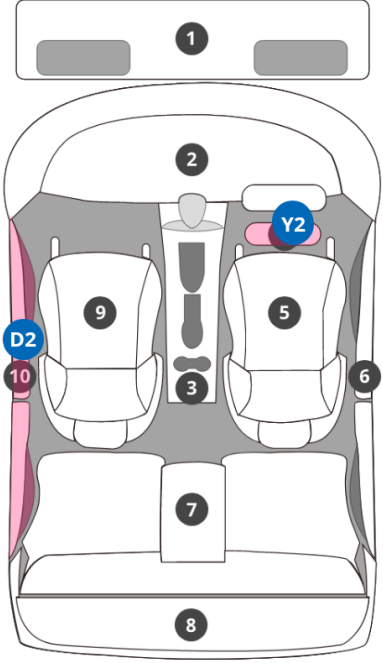
<p>a : Cut, Fray d : Loose, Deformed k : Animal Hair s : Smell t : Cigarette Burns x : Defective y : Stain</p>

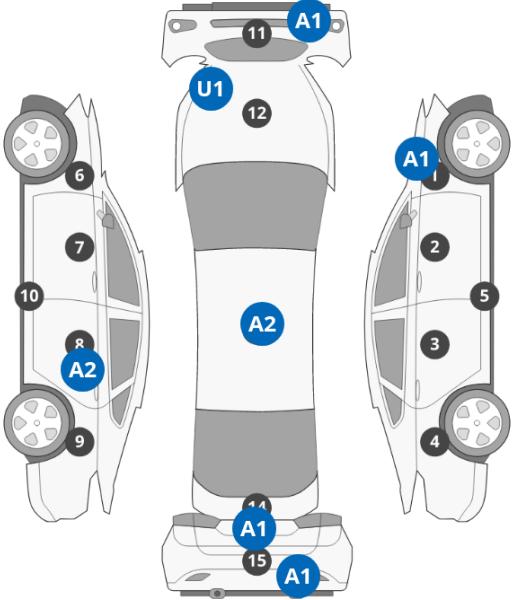
<p>A : Scratch AU : Scratch & Dent B : Modified C : Corrosion G : Stone chip P : Faded S : Rust SC : Rust & Corrosion U : Dent X : Defective Y : Crack, Gap</p>
<p>Remarks (L) Front Floor Mat - Worked - Small / (R) Front Floor Mat - Grime - Small / (L) Front Trim - Worked - Small</p>	<p>Remarks (L) Rear Door, Molding - Scratch - Small / Bonnet, Headlight - Dent - Minimal / Front Bumper, Grille, Lamps - Scratch - Minimal / (R) Front Fender, Molding - Scratch - Minimal / Rear Bumper, Lamps, Panels - Scratch - Minimal / Trunk Hood, Rear Gate - Scratch - Minimal / Roof - Scratch - Small</p>
Frame Evaluation : A	Functional Evaluation : A
<p>Remarks Defects not found</p>	<p>Remarks Spare Key - Issue - Unexist</p>

<p>Inspector Notes</p>
<p>With LTO plate and warranty booklet, No Tools and Jack and Sparetire, No spare key, Scratch headlight and tail light.</p>
