General Information

Make	Toyota	Model	Vios
YOM	2022	Odo Meter Reading	170,965
Registration No.	DAS1589	Chassis No.	PA1B18F3XN4188164
CC	1.3	Transmission	M/T
Fuel Type	Gas	Type of Body	Sedan
Colour	Green

Body / Panel Condition

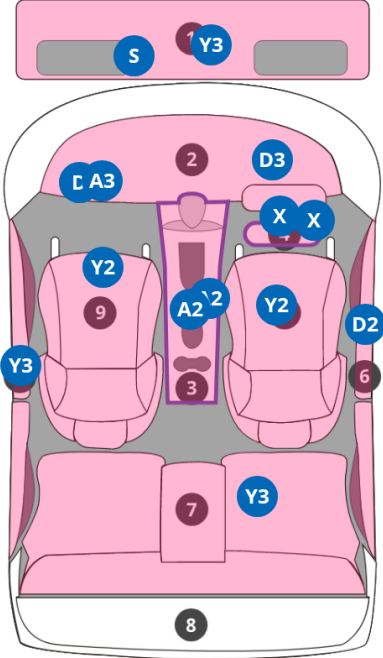
Interior Evaluation : D	Exterior Evaluation : E

<p>a : Cut, Fray d : Loose, Deformed k : Animal Hair s : Smell t : Cigarette Burns x : Defective y : Stain</p>

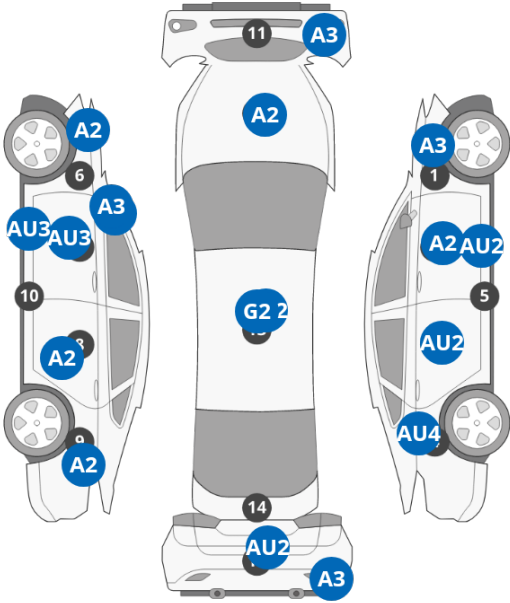
<p>A : Scratch AU : Scratch & Dent B : Modified C : Corrosion G : Stone chip P : Faded S : Rust SC : Rust & Corrosion U : Dent X : Defective Y : Crack, Gap</p>
<p>Remarks Rear Seat - Grime - Medium / Mat Other - Missing - Yes / Overall Interior - Smell - Yes / Ceiling - Grime - Medium / (R) Front Seat - Grime - Small / (L) Front Seat - Grime - Small / (L) Front Floor Mat - Missing - Yes / (L) Front Trim - Grime - Medium / (R) Front Trim - Worked - Small / Glove Box - Loose, Deformed - Medium / Console, Switches, Vents - Worn, Scratch, Cut, Crack - Small / Dashboard - Traces of Adhesive Tape - Yes / Steering Wheel - Worn, Peel, Crack - Medium / Knobs - Worn, Peel, Crack - Small / Display, Audio System - Missing - Yes</p>	<p>Remarks Front Bumper, Grille, Lamps - Scratch - Medium / (R) Front Fender, Molding - Scratch - Medium / (R) Front Door, Molding - Scratch - Small / (R) Rear Door, Molding - Scratch & Dent - Small / (R) Rear Fender, Molding - Scratch & Dent - Large / Rear Bumper, Lamps, Panels - Scratch - Medium / Trunk Hood, Rear Gate - Scratch & Dent - Small / (L) Rear Fender, Molding - Scratch - Small / (L) Rear Door, Molding - Scratch - Small / (L) Front Door, Molding - Scratch & Dent - Medium / (L) Step, In-panel, Side Spoiler - Scratch & Dent - Medium / (R) Step, In-panel, Side Spoiler - Scratch & Dent - Small / Roof - Scratch & Dent - Small / Bonnet, Headlight - Scratch - Small / (L) Front Fender, Molding - Scratch - Small / (L) Mirror - Faded(Color, Gloss) - Yes / (L) Mirror - Scratch - Medium / Front Windshield - Scratch, Stone chip - Small</p>
