General Information

Make	Toyota	Model	Vios
YOM	2025	Odo Meter Reading	17,746
Registration No.	CCG1195	Chassis No.	PA1B18F37R4278121
CC	1.3	Transmission	CVT
Fuel Type	Gas	Type of Body	Sedan
Colour	Blackish Red Mica

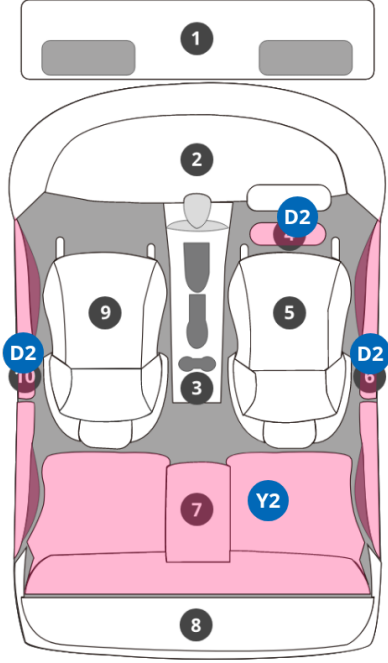
Interior Evaluation : A	Exterior Evaluation : B

<p>a : Cut, Fray d : Loose, Deformed k : Animal Hair s : Smell t : Cigarette Burns x : Defective y : Stain</p>

<p>A : Scratch AU : Scratch & Dent B : Modified C : Corrosion G : Stone chip P : Faded S : Rust SC : Rust & Corrosion U : Dent X : Defective Y : Crack, Gap</p>
<p>Remarks Rear Seat - Grime - Small / (L) Front Floor Mat - Worked - Small / (L) Front Trim - Worked - Small / (R) Front Trim - Worked - Small</p>	<p>Remarks Trunk Hood, Rear Gate - Dent - Medium / Rear Bumper, Lamps, Panels - Scratch & Dent - Small / (L) Rear Fender, Molding - Scratch - Small / (L) Rear Door, Molding - Scratch - Minimal / (L) Mirror - Scratch - Minimal / (L) Step, In-panel, Side Spoiler - Scratch & Dent - Minimal / Member (Bolted) - Dent - Yes / (R) Front Door, Molding - Scratch - Small / (R) Rear Door, Molding - Scratch - Minimal / (R) Rear Fender, Molding - Scratch - Minimal / Roof - Scratch - Small / Bonnet, Headlight - Scratch - Minimal / (R) Mirror - Scratch - Minimal / (R) Front Fender, Molding - Scratch - Minimal</p>

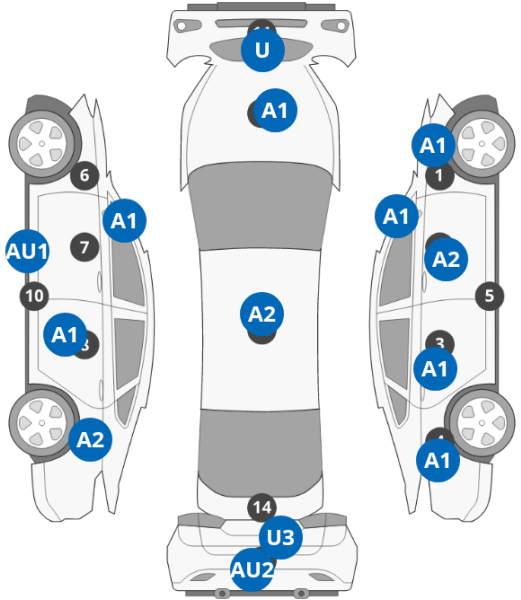
<p>Inspector Notes</p>
<p>With LTO plate and Sparetire and Jack and Incomplete Tools, No warranty booklet and Scratch headlight and tail light, no spare key, worn tires and Sparetire.</p>
