General Information

Make	Toyota	Model	Rush
YOM	2023	Odo Meter Reading	17,839
Registration No.	NFO3299	Chassis No.	MHKE8FF3PNK047413
CC	1.5	Transmission	A/T
Fuel Type	Gas	Type of Body	SUV
Colour	Red

Body / Panel Condition

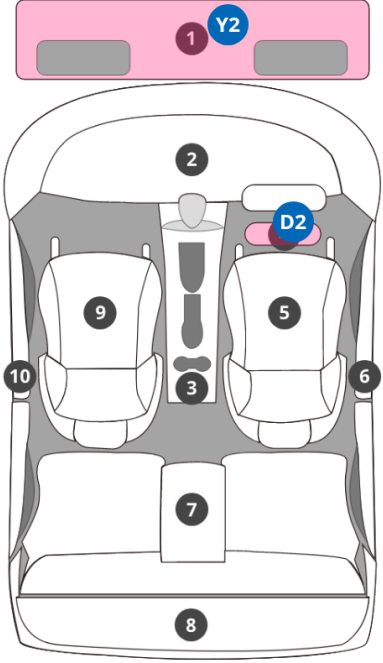
Interior Evaluation : A	Exterior Evaluation : B

<p>a : Cut, Fray d : Loose, Deformed k : Animal Hair s : Smell t : Cigarette Burns x : Defective y : Stain</p>

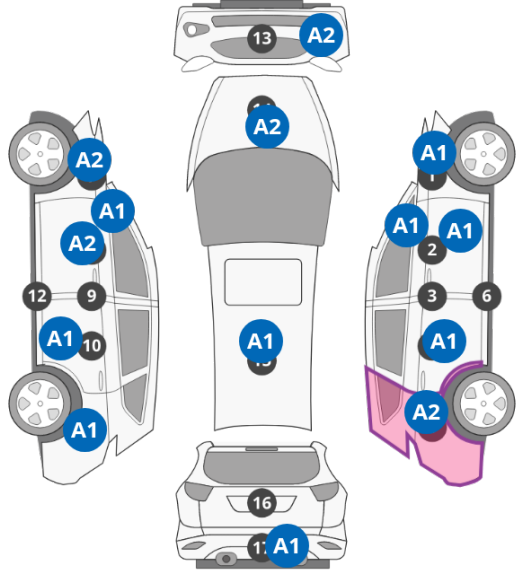
<p>A : Scratch AU : Scratch & Dent B : Modified C : Corrosion G : Stone chip P : Faded S : Rust SC : Rust & Corrosion U : Dent X : Defective Y : Crack, Gap</p>
<p>Remarks Ceiling - Grime - Small / (L) Front Floor Mat - Worked - Small</p>	<p>Remarks (R) Rear Fender - Repair Traces - Yes / Front Bumper, Grille, Lamps - Scratch - Small / Bonnet, Headlight - Scratch - Small / (L) Mirror - Scratch - Minimal / (L) Front Fender, Molding - Scratch - Small / (L) Front Door, Molding - Scratch - Small / (L) Rear Door, Molding - Scratch - Minimal / (L) Rear Fender, Molding - Scratch - Minimal / Rear Bumper, Lamps, Panels - Scratch - Minimal / (R) Rear Fender, Molding - Repair mark - Yes / (R) Rear Door, Molding - Scratch - Minimal / (R) Rear Fender, Molding - Scratch - Small / (R) Front Door, Molding - Scratch - Minimal / (R) Mirror - Scratch - Minimal / (R) Front Fender, Molding - Scratch - Minimal / Roof - Scratch - Minimal</p>
