General Information

Make	Toyota	Model	Hiace
YOM	2023	Odo Meter Reading	48,813
Registration No.	NFO9796	Chassis No.	JTFNAFAP1N8027788
CC	2.8	Transmission	M/T
Fuel Type	Diesel	Type of Body	Van
Colour	White

Body / Panel Condition

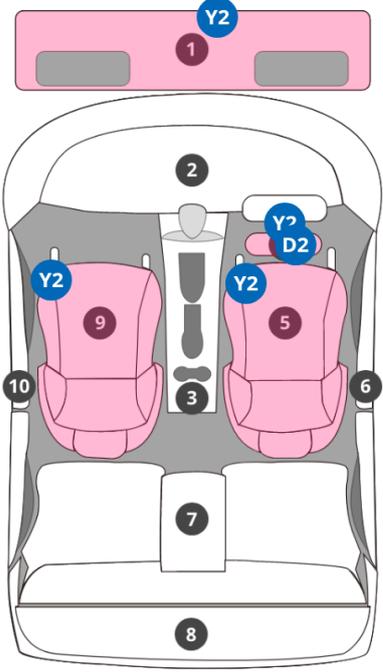
Interior Evaluation : B	Exterior Evaluation : D

<p>a : Cut, Fray d : Loose, Deformed k : Animal Hair s : Smell t : Cigarette Burns x : Defective y : Stain</p>

<p>A : Scratch AU : Scratch & Dent B : Modified C : Corrosion G : Stone chip P : Faded S : Rust SC : Rust & Corrosion U : Dent X : Defective Y : Crack, Gap</p>
<p>Remarks (R) Front Seat - Grime - Small / (L) Front Seat - Grime - Small / Mat Other - Grime - Small / (L) Front Floor Mat - Worked - Small / Ceiling - Grime - Small</p>	<p>Remarks Bonnet - Repair Traces - Yes / (R) Rear Fender - Repair Traces - Yes / (R) Rear Door - Repair Traces - Yes / (R) Front Fender, Molding - Scratch - Minimal / (R) Mirror - Scratch - Minimal / (R) Front Door, Molding - Scratch - Small / (R) Center Panel - Scratch - Medium / (R) Rear Door, Molding - Scratch - Minimal / (R) Rear Fender, Molding - Repair mark - Yes / Trunk Hood, Rear Gate - Repair mark - Yes / (R) Rear Fender, Molding - Scratch - Minimal / Trunk Hood, Rear Gate - Scratch - Small / Rear Bumper, Lamps, Panels - Scratch - Small / (L) Rear Fender, Molding - Scratch - Medium / (L) Rear Door, Molding - Scratch - Minimal / (L) Front Door, Molding - Scratch - Small / (L) Front Fender, Molding - Scratch - Minimal / (L) Mirror - Scratch - Minimal / Bonnet, Headlight - Dent - Medium / Front Bumper, Grille, Lamps - Scratch - Medium</p>

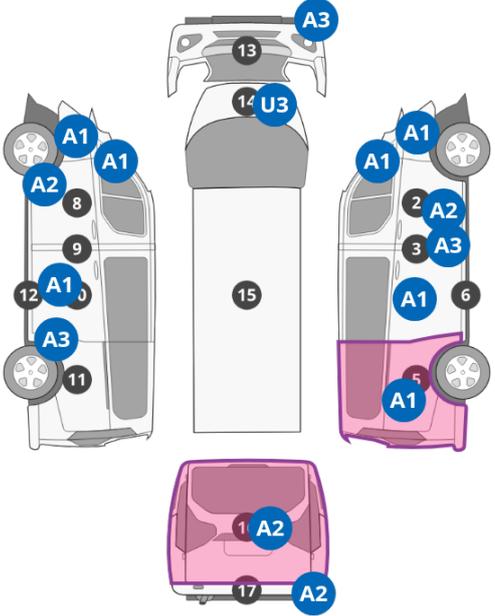
<p>Inspector Notes</p>
<p>no warranty booklet, with jack, no tools, with spare tire and LTO PLATE, scratches on tail light, brake light issue</p>
