General Information

Make	Toyota	Model	Vios
YOM	2024	Odo Meter Reading	39,388
Registration No.	NFR1407	Chassis No.	PA1B18F32R4247729
CC	1.3	Transmission	CVT
Fuel Type	Gas	Type of Body	Sedan
Colour	Blue

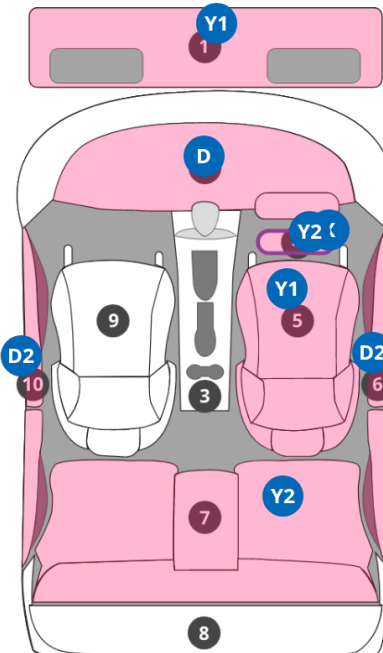
Interior Evaluation : B	Exterior Evaluation : D

<p>a : Cut, Fray d : Loose, Deformed k : Animal Hair s : Smell t : Cigarette Burns x : Defective y : Stain</p>

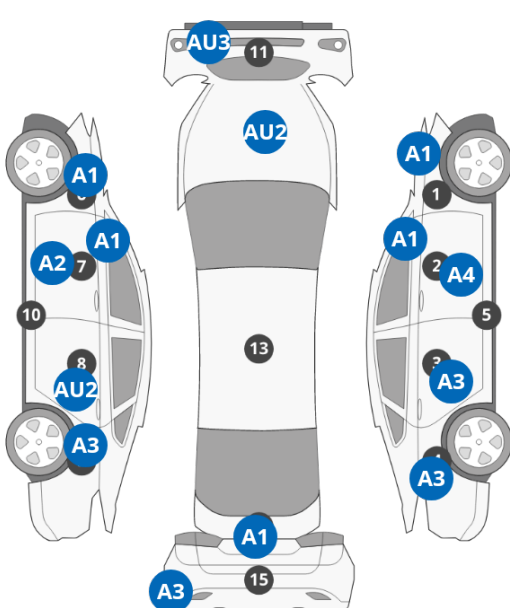
<p>A : Scratch AU : Scratch & Dent B : Modified C : Corrosion G : Stone chip P : Faded S : Rust SC : Rust & Corrosion U : Dent X : Defective Y : Crack, Gap</p>
<p>Remarks (L) Front Floor Mat - Missing - Yes / Rear Seat - Grime - Small / Mat Other - Grime - Small / (L) Front Trim - Worked - Small / (R) Front Trim - Worked - Small / Dashboard - Traces of Adhesive Tape - Yes / (R) Front Seat - Grime - Minimal / Ceiling - Grime - Minimal</p>	<p>Remarks (L) Rear Door, Molding - Scratch & Dent - Small / (L) Rear Fender, Molding - Scratch - Medium / Rear Bumper, Lamps, Panels - Scratch - Medium / Trunk Hood, Rear Gate - Scratch - Minimal / (R) Rear Fender, Molding - Scratch - Medium / (R) Rear Door, Molding - Scratch - Medium / (R) Front Door, Molding - Scratch - Large / (R) Mirror - Scratch - Minimal / Bonnet, Headlight - Scratch & Dent - Small / (R) Front Fender, Molding - Scratch - Minimal / (L) Mirror - Scratch - Minimal / (L) Front Door, Molding - Scratch - Small / (L) Front Fender, Molding - Scratch - Minimal / Front Bumper, Grille, Lamps - Scratch & Dent - Medium</p>
