## General Information

| Make | Toyota | Model | Vios |
| YOM | 2023 | Mileage | 31,081 |

## Body / Panel Condition

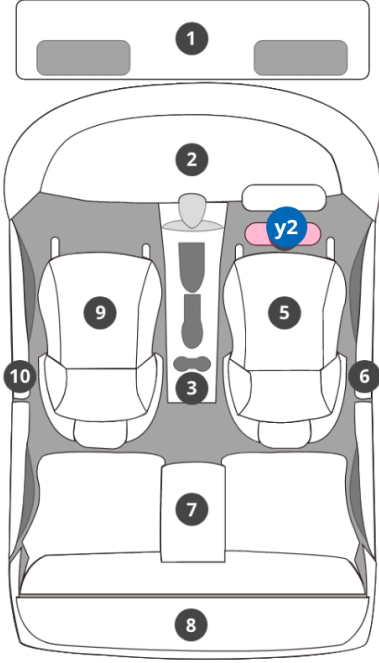
| Interior Evaluation : <span style="color: red; font-weight: bold;">A</span> | Exterior Evaluation : <span style="color: red; font-weight: bold;">C</span> |
|---|---|
| <b>Remarks</b><br>(L) Front Floor Mat - Grime - Small | <b>Remarks</b><br>Front Bumper, Grille, Lamps - Scratch - Medium / (R) Front Door, Molding - Scratch & Dent - Small / (R) Rear Door, Molding - Dent - Minimal / Trunk Hood, Rear Gate - Dent - Small / Rear Bumper, Lamps, Panels - Dent - Small / (L) Rear Door, Molding - Scratch - Medium / (L) Front Door, Molding - Scratch - Large / Roof - Dent - Small |
