General Information

Make	Toyota	Model	Vios
YOM	2025	Odo Meter Reading	28,894
Registration No.	CCJ1511	Chassis No.	PA1B18F38R4276443
CC	1.3	Transmission	CVT
Fuel Type	Gas	Type of Body	Sedan
Colour	Silver

Body / Panel Condition

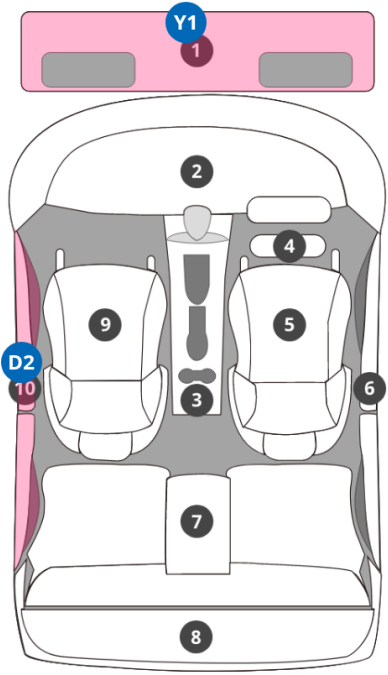
Interior Evaluation : A	Exterior Evaluation : B

<p>a : Cut, Fray d : Loose, Deformed k : Animal Hair s : Smell t : Cigarette Burns x : Defective y : Stain</p>

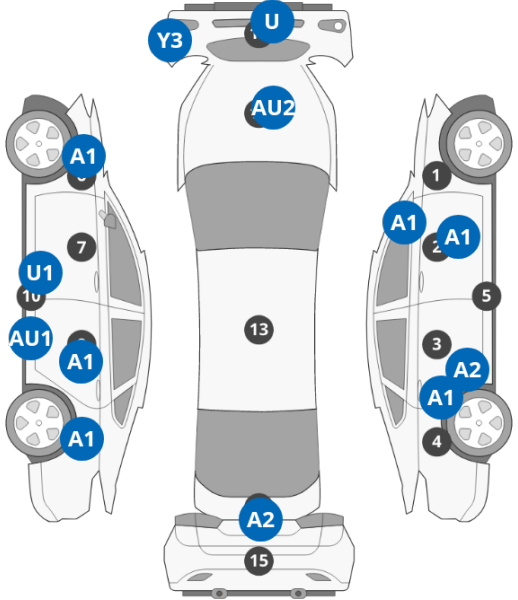
<p>A : Scratch AU : Scratch & Dent B : Modified C : Corrosion G : Stone chip P : Faded S : Rust SC : Rust & Corrosion U : Dent X : Defective Y : Crack, Gap</p>
<p>Remarks (L) Front Trim - Worked - Small / Ceiling - Grime - Minimal</p>	<p>Remarks Member (Bolted) - Dent - Yes / Front Bumper, Grille, Lamps - Crack, Gap - Medium / (L) Front Fender, Molding - Scratch - Minimal / (L) Front Door, Molding - Dent - Minimal / (L) Rear Door, Molding - Scratch - Minimal / (L) Step, In-panel, Side Spoiler - Scratch & Dent - Minimal / (L) Rear Fender, Molding - Scratch - Minimal / Trunk Hood, Rear Gate - Scratch - Small / (R) Rear Door, Molding - Scratch - Small / (R) Rear Fender, Molding - Scratch - Minimal / (R) Front Door, Molding - Scratch - Minimal / (R) Mirror - Scratch - Minimal / Bonnet, Headlight - Scratch & Dent - Small</p>

<p>Inspector Notes</p>
<p>With LTO plate and Sparetire and Warranty booklet, No Tools and Jack, No Spare key, Scratch headlight and tail light, Worn Tires and Sparetire.</p>
