General Information

Make	Toyota	Model	Vios
YOM	2025	Odo Meter Reading	4,045
Registration No.	CCJ3914	Chassis No.	PA1B18F3XR4272779
CC	1.3	Transmission	CVT
Fuel Type	Gas	Type of Body	Sedan
Colour	Red

Body / Panel Condition

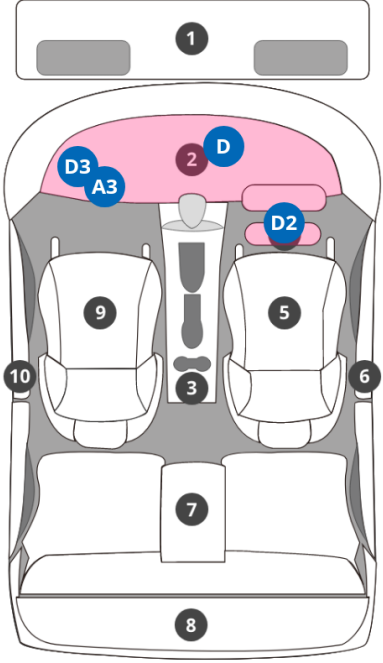
Interior Evaluation : B	Exterior Evaluation : B

<p>a : Cut, Fray d : Loose, Deformed k : Animal Hair s : Smell t : Cigarette Burns x : Defective y : Stain</p>

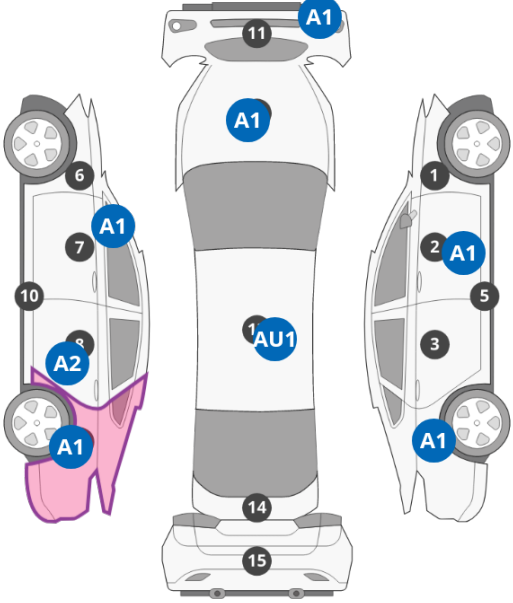
<p>A : Scratch AU : Scratch & Dent B : Modified C : Corrosion G : Stone chip P : Faded S : Rust SC : Rust & Corrosion U : Dent X : Defective Y : Crack, Gap</p>
<p>Remarks Dashboard - Loose, Deformed - Medium / (R) Front Floor Mat - Worked - Small / Dashboard - Traces of Adhesive Tape - Yes / Steering Wheel - Worn, Peel, Crack - Medium</p>	<p>Remarks (L) Rear Fender - Repair Traces - Yes / (L) Rear Fender, Molding - Repair mark - Yes / (L) Rear Fender, Molding - Scratch - Minimal / (L) Mirror - Scratch - Minimal / (L) Rear Door, Molding - Scratch - Small / (R) Front Door, Molding - Scratch - Minimal / (R) Rear Fender, Molding - Scratch - Minimal / Bonnet, Headlight - Scratch - Minimal / Roof - Scratch & Dent - Minimal / Front Bumper, Grille, Lamps - Scratch - Minimal</p>
