## General Information

<b>Make</b>	Toyota	<b>Model</b>	Wigo
<b>YOM</b>	2023	<b>Odo Meter Reading</b>	42,073
<b>Registration No.</b>	CCB3354	<b>Chassis No.</b>	MHKAA1BC7PJ002451
<b>CC</b>	1.0	<b>Transmission</b>	CVT
<b>Fuel Type</b>	Gas	<b>Type of Body</b>	Hatchback
<b>Colour</b>	Red Mica Metallic

## Body / Panel Condition

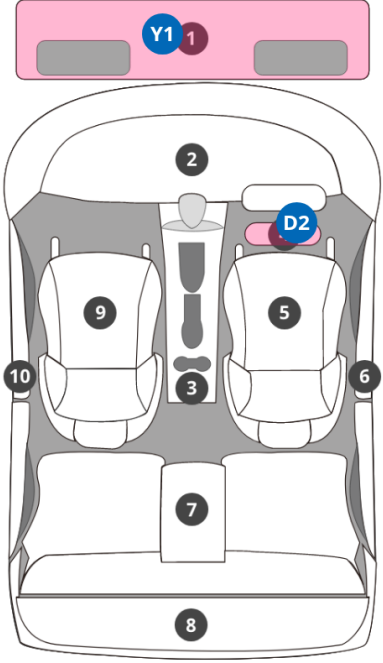
<b>Interior Evaluation :</b> <span style="color: red; font-weight: bold; font-size: 1.2em;">A</span>	<b>Exterior Evaluation :</b> <span style="color: red; font-weight: bold; font-size: 1.2em;">C</span>

<p><b>a</b> : Cut, Fray <b>d</b> : Loose, Deformed <b>k</b> : Animal Hair <b>s</b> : Smell <b>t</b> : Cigarette Burns <b>x</b> : Defective <b>y</b> : Stain</p>

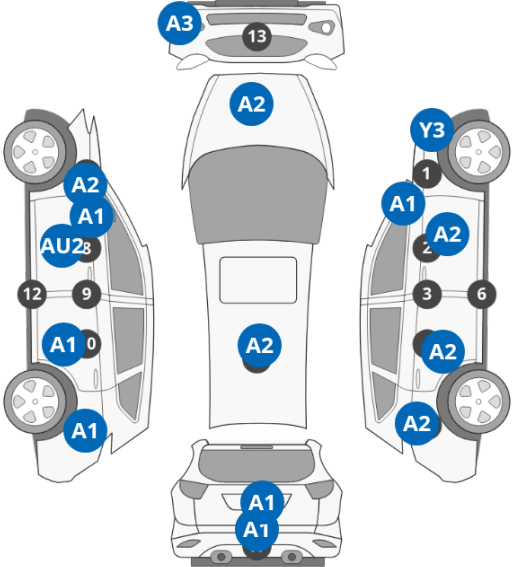
<p><b>A</b> : Scratch <b>AU</b> : Scratch &amp; Dent <b>B</b> : Modified <b>C</b> : Corrosion <b>G</b> : Stone chip <b>P</b> : Faded <b>S</b> : Rust <b>SC</b> : Rust &amp; Corrosion <b>U</b> : Dent <b>X</b> : Defective <b>Y</b> : Crack, Gap</p>
<p><b>Remarks</b> (L) Front Floor Mat - Worked - Small / Ceiling - Grime - Minimal</p>	<p><b>Remarks</b> (L) Front Door, Molding - Scratch &amp; Dent - Small / (L) Rear Door, Molding - Scratch - Minimal / (L) Front Fender, Molding - Scratch - Small / (L) Mirror - Scratch - Minimal / Front Bumper, Grille, Lamps - Scratch - Medium / Bonnet, Headlight - Scratch - Small / (R) Front Fender, Molding - Crack, Gap - Medium / (R) Front Door, Molding - Scratch - Small / (R) Rear Door, Molding - Scratch - Small / (R) Mirror - Scratch - Minimal / (R) Rear Fender, Molding - Scratch - Small / Rear Bumper, Lamps, Panels - Scratch - Minimal / Trunk Hood, Rear Gate - Scratch - Minimal / (L) Rear Fender, Molding - Scratch - Minimal / Roof - Scratch - Small</p>
