General Information

Make	Toyota	Model	Veloz
YOM	2024	Odo Meter Reading	11,441
Registration No.	CCA9467	Chassis No.	MHFAB1BYXR3107516
CC	1.5	Transmission	CVT
Fuel Type	Gas	Type of Body	SUV
Colour	Gray

Body / Panel Condition

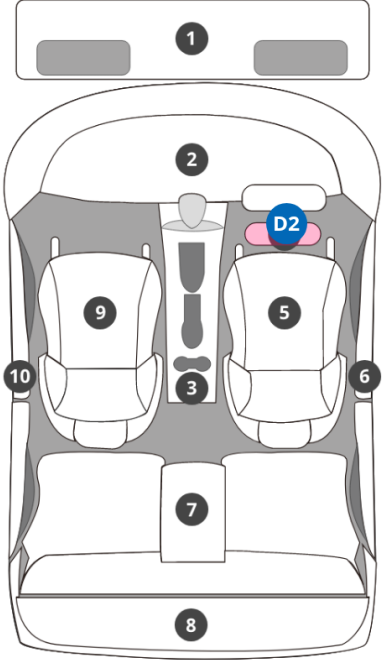
Interior Evaluation : A	Exterior Evaluation : A

<p>a : Cut, Fray d : Loose, Deformed k : Animal Hair s : Smell t : Cigarette Burns x : Defective y : Stain</p>

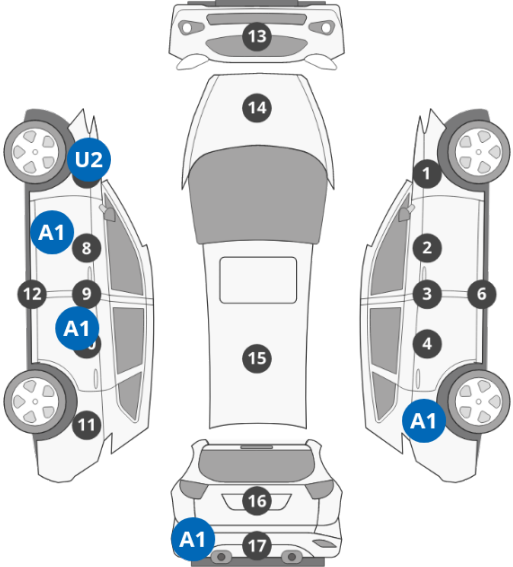
<p>A : Scratch AU : Scratch & Dent B : Modified C : Corrosion G : Stone chip P : Faded S : Rust SC : Rust & Corrosion U : Dent X : Defective Y : Crack, Gap</p>
Remarks (L) Front Floor Mat - Worked - Small	Remarks (L) Front Fender, Molding - Dent - Small / (L) Front Door, Molding - Scratch - Minimal / (L) Rear Door, Molding - Scratch - Minimal / (R) Rear Fender, Molding - Scratch - Minimal / Rear Bumper, Lamps, Panels - Scratch - Minimal
Frame Evaluation : A	Functional Evaluation : C
Remarks Defects not found	Remarks Warning Lamps - Issue - Yes
