General Information

Make	Toyota	Model	Innova
YOM	2024	Odo Meter Reading	25,287
Registration No.	CCC9249	Chassis No.	PA2JA8EM9R0142114
CC	2.8	Transmission	A/T
Fuel Type	Diesel	Type of Body	Wagon
Colour	Blackish Red Mica

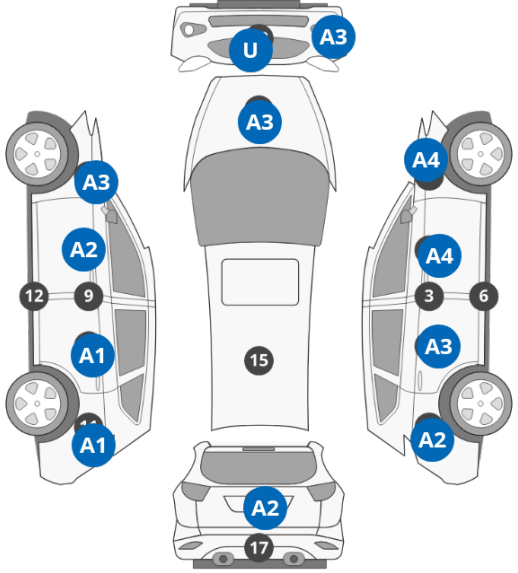
</div> <p>A : Scratch AU : Scratch & Dent B : Modified C : Corrosion G : Stone chip P : Faded S : Rust SC : Rust & Corrosion U : Dent X : Defective Y : Crack, Gap</p>
Remarks Defects not found	Remarks (L) Front Fender, Molding - Scratch - Medium / Member (Bolted) - Dent - Yes / Front Bumper, Grille, Lamps - Scratch - Medium / (R) Front Fender, Molding - Scratch - Large / (R) Front Door, Molding - Scratch - Large / (R) Rear Door, Molding - Scratch - Medium / Bonnet, Headlight - Scratch - Medium / (L) Rear Door, Molding - Scratch - Minimal / (L) Front Door, Molding - Scratch - Small / (L) Rear Fender, Molding - Scratch - Minimal / (R) Rear Fender, Molding - Scratch - Small / Trunk Hood, Rear Gate - Scratch - Small
