## General Information

| Make | Toyota | Model | Vios |
| YOM | 2021 | Odo Meter Reading | 41,366 |
| Registration No. | FAI5361 | Chassis No. | PA1B18F34M4156843 |

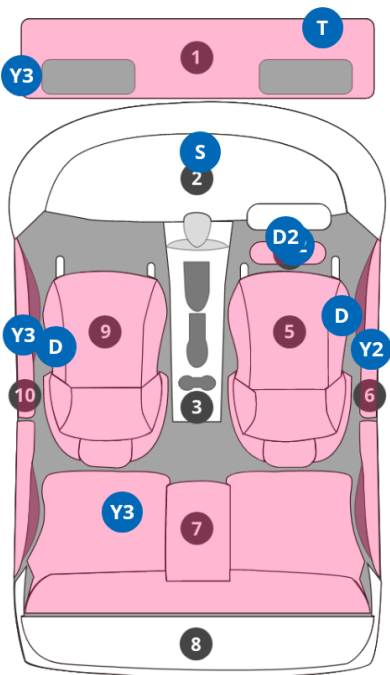
| Interior Evaluation : <b>D</b> | Exterior Evaluation : <b>D</b> |
| <p><b>Remarks</b></p> <p>Rear Seat - Grime - Medium / (L) Front Floor Mat - Worked - Small / (R) Front Floor Mat - Worked - Small / (L) Front Seat - Worn - Yes / Ceiling - Cigarette Burns - Burnt, Hole / Ceiling - Grime - Medium / (R) Front Seat - Worn - Yes / (R) Front Trim - Grime - Small / (L) Front Trim - Grime - Medium / Overall Interior - Smell - Yes</p> | <p><b>Remarks</b></p> <p>(R) Front Fender - Repair Traces - Yes / Bonnet - Repair Traces - Yes / (L) Front Fender - Repair Traces - Yes / Member (Bolted) - Dent - Yes / (R) Mirror - Scratch - Small / (R) Front Fender, Molding - Scratch - Small / (R) Front Door, Molding - Scratch - Small / (R) Step, In-panel, Side Spoiler - Scratch &amp; Dent - Large / (R) Rear Door, Molding - Scratch - Small / (R) Rear Fender, Molding - Scratch - Small / Rear Bumper, Lamps, Panels - Scratch - Small / Trunk Hood, Rear Gate - Scratch - Small / (L) Rear Fender, Molding - Scratch - Small / (L) Rear Door, Molding - Scratch &amp; Dent - Small / (L) Front Door, Molding - Scratch - Small / (L) Mirror - Scratch - Minimal / (L) Front Fender, Molding - Scratch &amp; Dent - Minimal / Front Bumper, Grille, Lamps - Scratch - Small / Bonnet, Headlight - Scratch - Medium / Roof - Scratch - Small</p> |

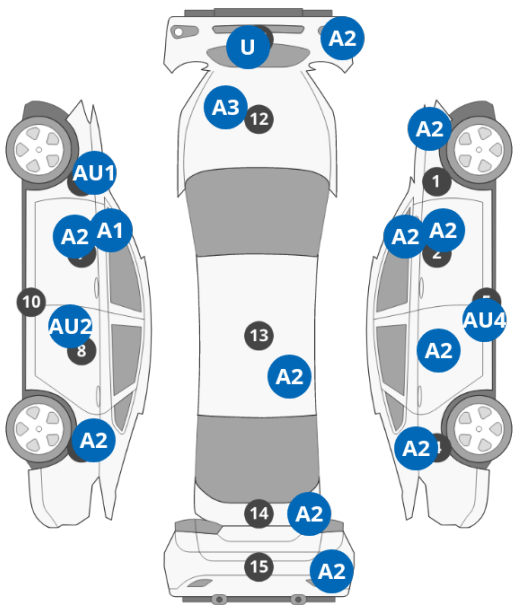
| Inspector Notes |
|---|
| with warranty booklet, no jack and tools, with spare tire, with LTO plate, possible flooding, scratched and cracked tail light, worn tires |
