General Information

Make	Toyota	Model	Vios
YOM	2022	Odo Meter Reading	21,384
Registration No.	FAN5392	Chassis No.	PA1B18F37N4183505
CC	1.3	Transmission	CVT
Fuel Type	Gas	Type of Body	Sedan
Colour	Red

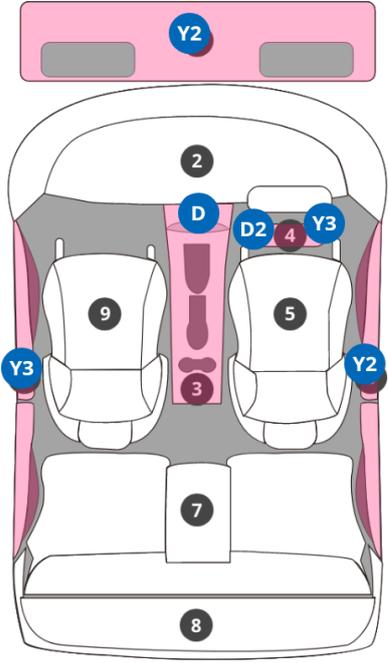
Interior Evaluation : B	Exterior Evaluation : D

<p>a : Cut, Fray d : Loose, Deformed k : Animal Hair s : Smell t : Cigarette Burns x : Defective y : Stain</p>

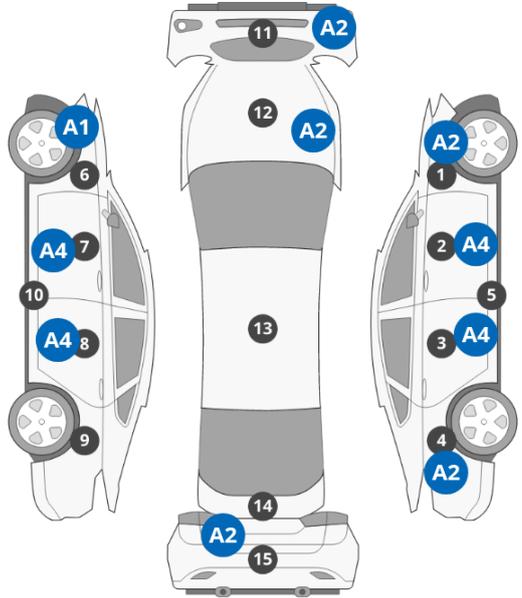
<p>A : Scratch AU : Scratch & Dent B : Modified C : Corrosion G : Stone chip P : Faded S : Rust SC : Rust & Corrosion U : Dent X : Defective Y : Crack, Gap</p>
<p>Remarks Ceiling - Grime - Small / (R) Front Trim - Grime - Small / (R) Front Floor Mat - Grime - Medium / (L) Front Trim - Grime - Medium / (L) Front Floor Mat - Worked - Small / Console, Switchs, Vents - Traces of Adhesive Tape - Yes</p>	<p>Remarks (L) Front Door, Molding - Scratch - Large / (L) Rear Door, Molding - Scratch - Large / (L) Front Fender, Molding - Scratch - Minimal / Bonnet, Headlight - Scratch - Small / Front Bumper, Grille, Lamps - Scratch - Small / (R) Front Fender, Molding - Scratch - Small / (R) Front Door, Molding - Scratch - Large / (R) Rear Door, Molding - Scratch - Large / (R) Rear Fender, Molding - Scratch - Small / Trunk Hood, Rear Gate - Scratch - Small</p>
