General Information

Make	Toyota	Model	Vios
YOM	2023	Odo Meter Reading	27,881
Registration No.	FAO1671 (NON MOVING)	Chassis No.	PA1B18F36P4202001
CC	1.3	Transmission	CVT
Fuel Type	Gas	Type of Body	Sedan
Colour	Red Mica Metallic

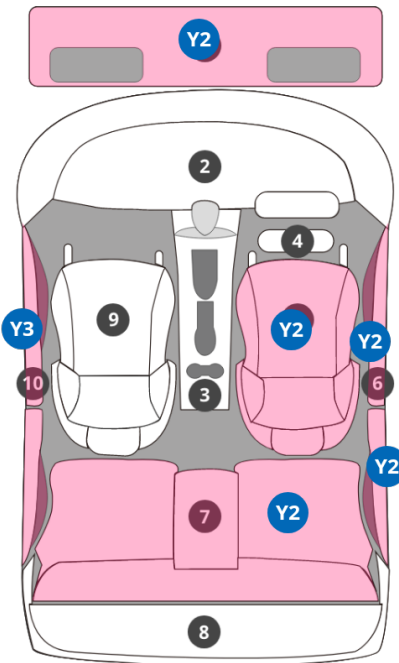
Interior Evaluation : B	Exterior Evaluation : C

<p>a : Cut, Fray d : Loose, Deformed k : Animal Hair s : Smell t : Cigarette Burns x : Defective y : Stain</p>

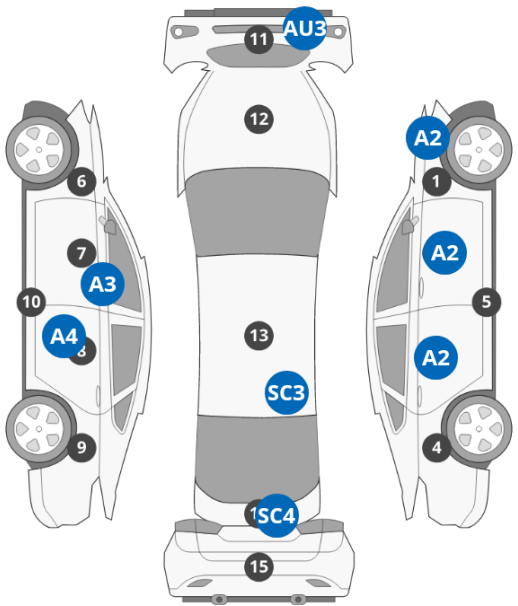
<p>A : Scratch AU : Scratch & Dent B : Modified C : Corrosion G : Stone chip P : Faded S : Rust SC : Rust & Corrosion U : Dent X : Defective Y : Crack, Gap</p>
<p>Remarks (R) Front Trim - Grime - Small / (R) Rear Trim - Grime - Small / (L) Front Trim - Grime - Medium / (R) Front Seat - Grime - Small / Rear Seat - Grime - Small / Ceiling - Grime - Small</p>	<p>Remarks (R) Front Door - Repair Traces - Yes / Trunk Hood, Rear Gate - Rust, Corrosion - Large / (L) Rear Door, Molding - Scratch - Large / (L) Front Door, Molding - Scratch - Medium / Front Bumper, Grille, Lamps - Scratch & Dent - Medium / (R) Front Fender, Molding - Scratch - Small / (R) Front Door, Molding - Scratch - Small / (R) Rear Door, Molding - Scratch - Small / Roof - Rust, Corrosion - Medium</p>
