General Information

Make	Toyota	Model	Innova
YOM	2023	Odo Meter Reading	41,966
Registration No.	FAO6646	Chassis No.	PA2JA8EM1P0124106
CC	2.8	Transmission	A/T
Fuel Type	Diesel	Type of Body	Wagon
Colour	Red Mica Metallic

Body / Panel Condition

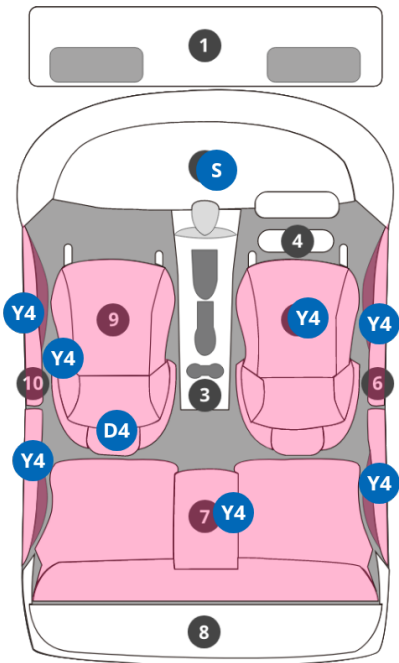
Interior Evaluation : E	Exterior Evaluation : E

<p>a : Cut, Fray d : Loose, Deformed k : Animal Hair s : Smell t : Cigarette Burns x : Defective y : Stain</p>

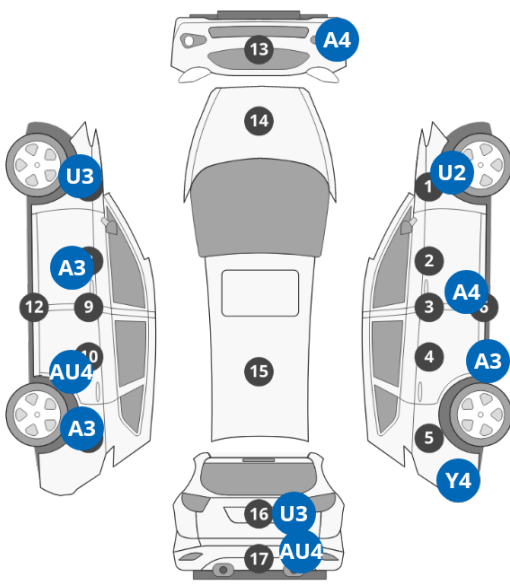
<p>A : Scratch AU : Scratch & Dent B : Modified C : Corrosion G : Stone chip P : Faded S : Rust SC : Rust & Corrosion U : Dent X : Defective Y : Crack, Gap</p>
<p>Remarks Overall Interior - Smell - Yes / (R) Front Trim - Grime - Large / (R) Front Seat - Grime - Large / (R) Rear Trim - Grime - Large / Rear Seat - Grime - Large / (L) Rear Trim - Grime - Large / (L) Front Trim - Grime - Large / (L) Front Seat Head Rest - Worked - Large / (L) Front Seat belt - Grime - Large</p>	<p>Remarks (L) Rear Door, Molding - Scratch & Dent - Large / (L) Front Door, Molding - Scratch - Medium / (L) Front Fender, Molding - Dent - Medium / (L) Rear Fender, Molding - Scratch - Medium / Trunk Hood, Rear Gate - Dent - Medium / Rear Bumper, Lamps, Panels - Scratch & Dent - Large / (R) Rear Fender, Molding - Crack, Gap - Large / (R) Step, In-panel, Side Spoiler - Scratch - Medium / (R) Front Door, Molding - Scratch - Large / (R) Front Fender, Molding - Dent - Small / Front Bumper, Grille, Lamps - Scratch - Large</p>
