General Information

Make	Toyota	Model	Vios
YOM	2023	Odo Meter Reading	43,086
Registration No.	FAO7170	Chassis No.	PA1B18F37P4214903
CC	1.3	Transmission	CVT
Fuel Type	Gas	Type of Body	Sedan
Colour	Silver

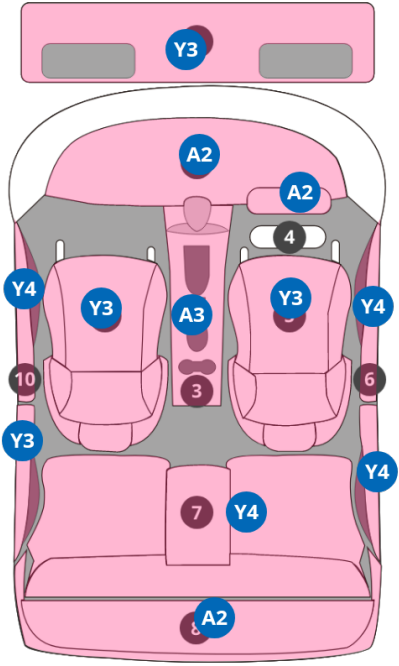
Interior Evaluation : E	Exterior Evaluation : E

<p>a : Cut, Fray d : Loose, Deformed k : Animal Hair s : Smell t : Cigarette Burns x : Defective y : Stain</p>

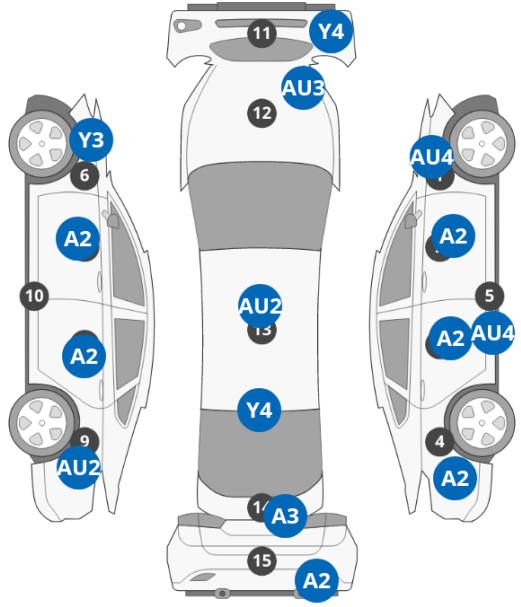
<p>A : Scratch AU : Scratch & Dent B : Modified C : Corrosion G : Stone chip P : Faded S : Rust SC : Rust & Corrosion U : Dent X : Defective Y : Crack, Gap</p>
<p>Remarks (R) Front Seat - Grime - Medium / (R) Front Trim - Grime - Large / (R) Rear Trim - Grime - Large / Rear Seat - Grime - Large / Trunk Room - Worn, Scratch, Cut, Crack - Small / (L) Rear Trim - Grime - Medium / (L) Front Trim - Grime - Large / (L) Front Seat - Grime - Medium / Steering Wheel - Worn, Peel, Crack - Small / Ceiling - Grime - Medium / Dashboard - Worn, Scratch, Cut, Crack - Small / Console, Switchs, Vents - Worn, Scratch, Cut, Crack - Medium</p>	<p>Remarks (L) Rear Door, Molding - Scratch - Small / (L) Rear Fender, Molding - Scratch & Dent - Small / Trunk Hood, Rear Gate - Scratch - Medium / Rear Bumper, Lamps, Panels - Scratch - Small / (R) Rear Fender, Molding - Scratch - Small / (R) Rear Door, Molding - Scratch - Small / (R) Step, In-panel, Side Spoiler - Scratch & Dent - Large / (R) Front Door, Molding - Scratch - Small / (R) Front Fender, Molding - Scratch & Dent - Large / Bonnet, Headlight - Scratch & Dent - Medium / Front Bumper, Grille, Lamps - Crack, Gap - Large / Roof - Scratch & Dent - Small / (L) Front Fender, Molding - Crack, Gap - Medium / (L) Front Door, Molding - Scratch - Small / Rear Windshield - Damaged - Large</p>
