General Information

Make	Toyota	Model	Vios
YOM	2023	Odo Meter Reading	20,142
Registration No.	FAO7867	Chassis No.	PA1B18F33P4212033
CC	1.3	Transmission	CVT
Fuel Type	Gas	Type of Body	Sedan
Colour	Green

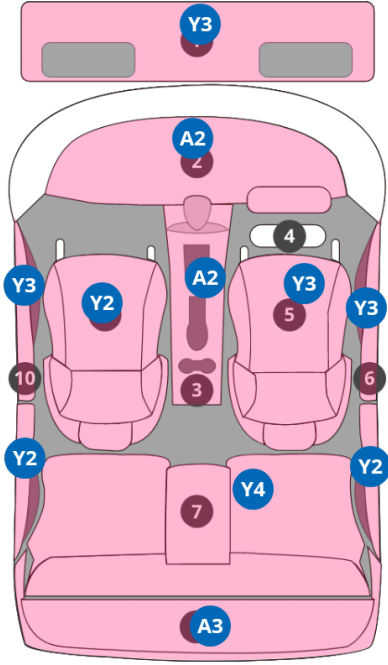
Interior Evaluation : D	Exterior Evaluation : E

<p>a : Cut, Fray d : Loose, Deformed k : Animal Hair s : Smell t : Cigarette Burns x : Defective y : Stain</p>

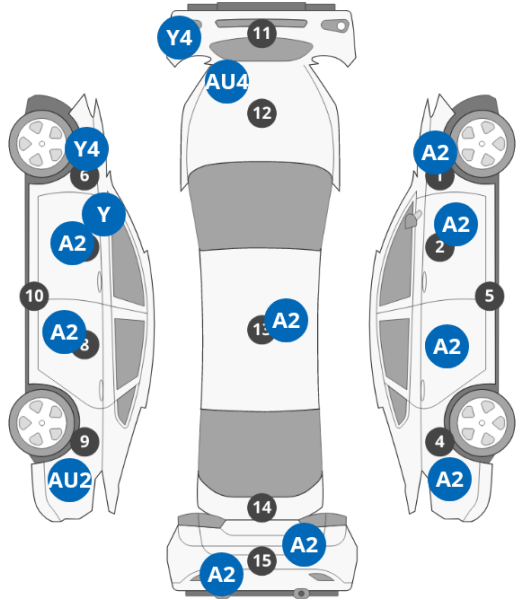
<p>A : Scratch AU : Scratch & Dent B : Modified C : Corrosion G : Stone chip P : Faded S : Rust SC : Rust & Corrosion U : Dent X : Defective Y : Crack, Gap</p>
Remarks (L) Front Seat - Grime - Small / (L) Front Trim - Grime - Medium / (L) Rear Trim - Grime - Small / Rear Seat - Grime - Large / (R) Rear Trim - Grime - Small / (R) Front Seat - Grime - Medium / Console, Switches, Vents - Worn, Scratch, Cut, Crack - Small / Ceiling - Grime - Medium / Dashboard - Worn, Scratch, Cut, Crack - Small / (R) Front Trim - Grime - Medium / Trunk Room - Worn, Scratch, Cut, Crack - Medium	Remarks (L) Mirror - Crack - Damaged / (L) Front Fender, Molding - Crack, Gap - Large / Front Bumper, Grille, Lamps - Crack, Gap - Large / Bonnet, Headlight - Scratch & Dent - Large / (R) Front Fender, Molding - Scratch - Small / (R) Front Door, Molding - Scratch - Small / (R) Rear Door, Molding - Scratch - Small / Trunk Hood, Rear Gate - Scratch - Small / Rear Bumper, Lamps, Panels - Scratch - Small / (L) Rear Door, Molding - Scratch - Small / (L) Front Door, Molding - Scratch - Small / Roof - Scratch - Small / (R) Rear Fender, Molding - Scratch - Small / (L) Rear Fender, Molding - Scratch & Dent - Small
