General Information

Make	Toyota	Model	Vios
YOM	2023	Odo Meter Reading	28,274
Registration No.	FAP6771	Chassis No.	PA1B18F35P4221834
CC	1.3	Transmission	CVT
Fuel Type	Gas	Type of Body	Sedan
Colour	Silver

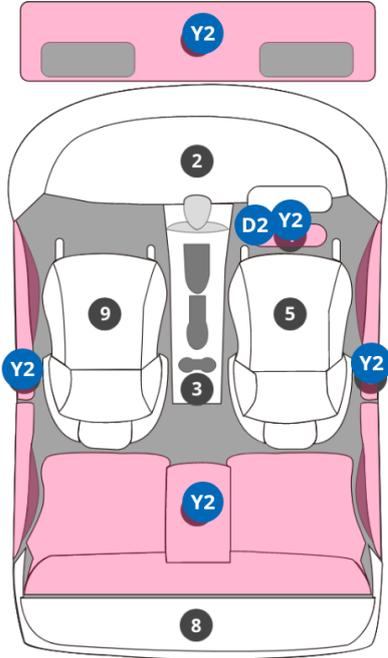
Interior Evaluation : B	Exterior Evaluation : C

<p>a : Cut, Fray d : Loose, Deformed k : Animal Hair s : Smell t : Cigarette Burns x : Defective y : Stain</p>

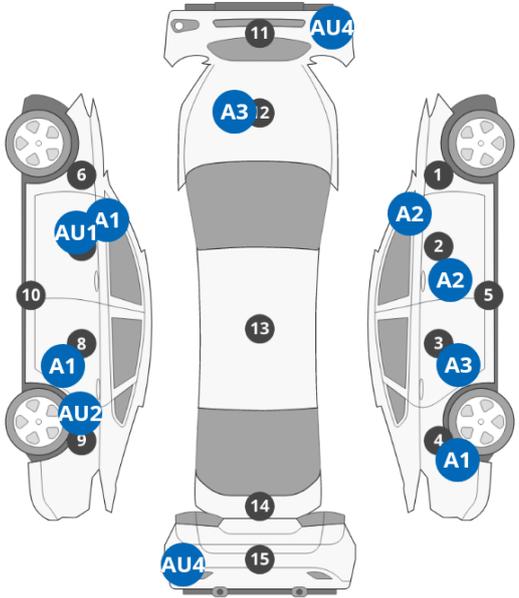
<p>A : Scratch AU : Scratch & Dent B : Modified C : Corrosion G : Stone chip P : Faded S : Rust SC : Rust & Corrosion U : Dent X : Defective Y : Crack, Gap</p>
<p>Remarks Ceiling - Grime - Small / (R) Front Trim - Grime - Small / Rear Seat - Grime - Small / Mat Other - Grime - Small / (L) Front Trim - Grime - Small / (L) Front Floor Mat - Worked - Small</p>	<p>Remarks Front Bumper, Grille, Lamps - Scratch & Dent - Large / Bonnet, Headlight - Scratch - Medium / (R) Mirror - Scratch - Small / (R) Front Door, Molding - Scratch - Small / (R) Rear Door, Molding - Scratch - Medium / (R) Rear Fender, Molding - Scratch - Minimal / Rear Bumper, Lamps, Panels - Scratch & Dent - Large / (L) Rear Door, Molding - Scratch - Minimal / (L) Mirror - Scratch - Minimal / (L) Front Door, Molding - Scratch & Dent - Minimal / (L) Rear Fender, Molding - Scratch & Dent - Small</p>

<p>Inspector Notes</p>
<p>Crack left taillight. Without warranty booklet,jack,tools and seat cover. With spare tire. 1 key. With LTO plate.</p>
