## General Information

| Make | Toyota | Model | Wigo |
| Registration No. | FAQ2145 | Chassis No. | MHKAA1BC0PJ005319 |

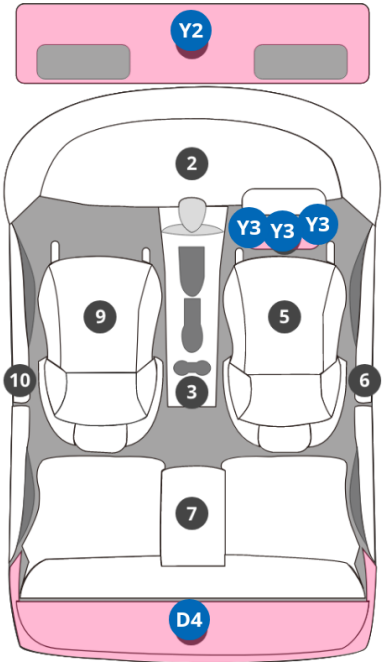
| Interior Evaluation : <b>C</b> | Exterior Evaluation : <b>E</b> |
|---|---|
| <p><b>Remarks</b><br/>Ceiling - Grime - Small / (R) Front Floor Mat - Grime - Medium / Mat Other - Grime - Medium / Trunk Room - Loose, Deformed - Large / (L) Front Floor Mat - Grime - Medium</p> | <p><b>Remarks</b><br/>Bonnet, Headlight - Scratch - Medium / Front Bumper, Grille, Lamps - Scratch &amp; Dent - Large / (R) Front Fender, Molding - Scratch - Large / (R) Front Door, Molding - Scratch - Large / (R) Mirror - Scratch - Small / (R) Rear Door, Molding - Scratch - Medium / (R) Rear Fender, Molding - Scratch &amp; Dent - Large / Rear Bumper, Lamps, Panels - Scratch &amp; Dent - Large / Trunk Hood, Rear Gate - Scratch - Small / (L) Rear Fender, Molding - Scratch - Minimal / (L) Rear Door, Molding - Scratch &amp; Dent - Medium / (L) Front Door, Molding - Scratch - Small / (L) Step, In-panel, Side Spoiler - Scratch - Small / (L) Front Fender, Molding - Scratch - Small</p> |
