General Information

Make	Toyota	Model	Vios
YOM	2025	Odo Meter Reading	9,863
Registration No.	FAQ8985	Chassis No.	PA1B18F36R4264162
CC	1.3	Transmission	CVT
Fuel Type	Gas	Type of Body	Sedan
Colour	Red Mica Metallic

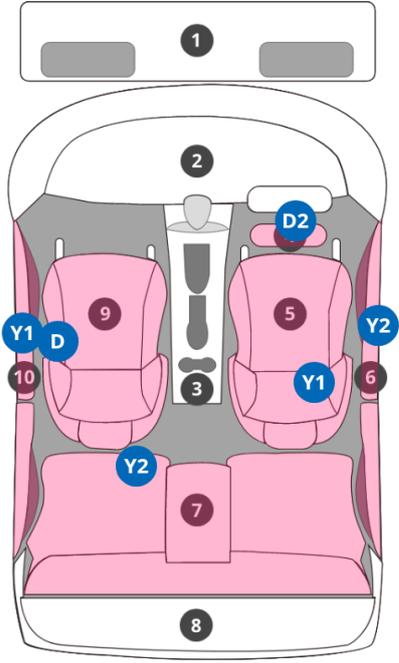
Interior Evaluation : B	Exterior Evaluation : C

<p>a : Cut, Fray d : Loose, Deformed k : Animal Hair s : Smell t : Cigarette Burns x : Defective y : Stain</p>

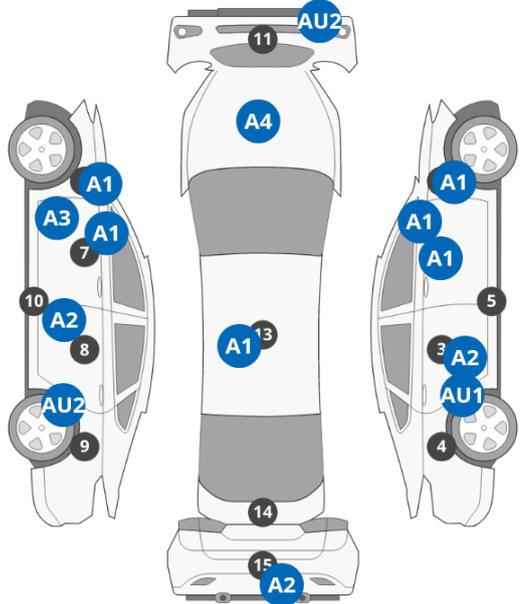
<p>A : Scratch AU : Scratch & Dent B : Modified C : Corrosion G : Stone chip P : Faded S : Rust SC : Rust & Corrosion U : Dent X : Defective Y : Crack, Gap</p>
<p>Remarks (L) Front Seat - Worn - Yes / (L) Front Trim - Grime - Minimal / (R) Front Trim - Grime - Small / Rear Seat - Grime - Small / (R) Front Seat - Grime - Minimal / (L) Front Floor Mat - Worked - Small</p>	<p>Remarks (R) Front Fender, Molding - Scratch - Minimal / (R) Front Door, Molding - Scratch - Minimal / (R) Rear Door, Molding - Scratch - Small / (R) Rear Fender, Molding - Scratch & Dent - Minimal / Rear Bumper, Lamps, Panels - Scratch - Small / (L) Rear Fender, Molding - Scratch & Dent - Small / (L) Rear Door, Molding - Scratch - Small / (L) Front Door, Molding - Scratch - Medium / (L) Mirror - Scratch - Minimal / (L) Front Fender, Molding - Scratch - Minimal / Front Bumper, Grille, Lamps - Scratch & Dent - Small / Bonnet, Headlight - Scratch - Large / Roof - Scratch - Minimal / (R) Mirror - Scratch - Minimal</p>
