## General Information

| Make | Toyota | Model | Vios |
| Registration No. | FAR5412 | Chassis No. | PA1B18F35R4251645 |

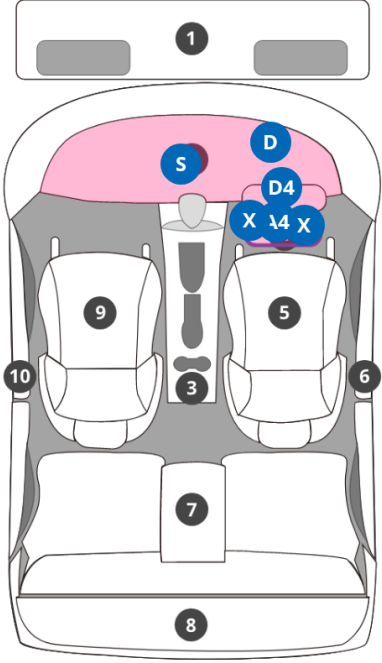
| Interior Evaluation : <b>C</b> | Exterior Evaluation : <b>E</b> |
| <p><b>Remarks</b><br/>Mat Other - Missing - Yes / Glove Box - Loose, Deformed - Large / (R) Front Floor Mat - Cut, Crack - Large / (L) Front Floor Mat - Missing - Yes / Dashboard - Traces of Adhesive Tape - Yes / Overall Interior - Smell - Yes</p> | <p><b>Remarks</b><br/>Front Bumper, Grille, Lamps - Scratch &amp; Dent - Large / (L) Rear Door, Molding - Dent - Small / Rear Bumper, Lamps, Panels - Scratch - Large / (L) Front Door, Molding - Crack, Gap - Small / (R) Rear Fender, Molding - Scratch - Large / (R) Rear Door, Molding - Scratch - Large / (R) Front Door, Molding - Scratch - Large / (R) Front Fender, Molding - Scratch - Large / Trunk Hood, Rear Gate - Repair mark - Yes / (L) Rear Fender, Molding - Scratch - Minimal / (L) Front Fender, Molding - Scratch - Minimal / Bonnet, Headlight - Dent - Small</p> |
