General Information

Make	Toyota	Model	Vios
YOM	2024	Odo Meter Reading	4,029
Registration No.	FAR7058	Chassis No.	PA1B18F30R4255554
CC	1.3	Transmission	CVT
Fuel Type	Gas	Type of Body	Sedan
Colour	Red Mica Metallic

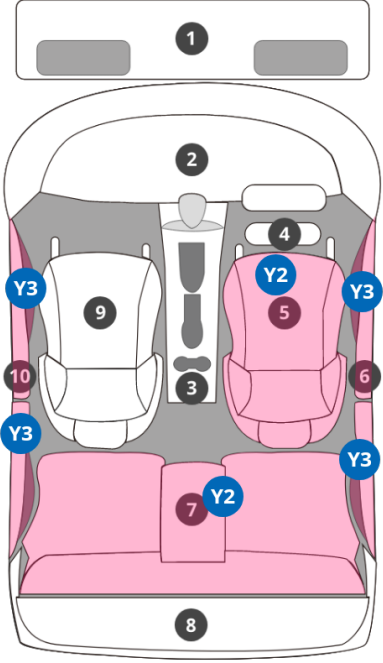
Interior Evaluation : C	Exterior Evaluation : C

<p>a : Cut, Fray d : Loose, Deformed k : Animal Hair s : Smell t : Cigarette Burns x : Defective y : Stain</p>

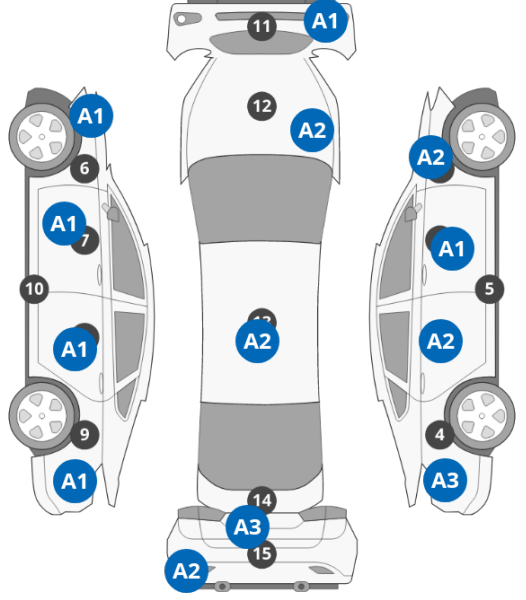
<p>A : Scratch AU : Scratch & Dent B : Modified C : Corrosion G : Stone chip P : Faded S : Rust SC : Rust & Corrosion U : Dent X : Defective Y : Crack, Gap</p>
<p>Remarks Rear Seat - Grime - Small / (R) Rear Trim - Grime - Medium / (R) Front Seat - Grime - Small / (R) Front Trim - Grime - Medium / (L) Front Trim - Grime - Medium / (L) Rear Trim - Grime - Medium</p>	<p>Remarks Trunk Hood, Rear Gate - Scratch - Medium / Rear Bumper, Lamps, Panels - Scratch - Small / (L) Rear Door, Molding - Scratch - Minimal / (L) Rear Fender, Molding - Scratch - Minimal / (L) Front Door, Molding - Scratch - Minimal / (L) Front Fender, Molding - Scratch - Minimal / Front Bumper, Grille, Lamps - Scratch - Minimal / Bonnet, Headlight - Scratch - Small / (R) Front Fender, Molding - Scratch - Small / (R) Front Door, Molding - Scratch - Minimal / (R) Rear Door, Molding - Scratch - Small / (R) Rear Fender, Molding - Scratch - Medium / Roof - Scratch - Small</p>
