General Information

Make	Toyota	Model	Raize
YOM	2024	Odo Meter Reading	20,023
Registration No.	FAR8477	Chassis No.	MHKAA1BA6RJ125580
CC	1.0	Transmission	CVT
Fuel Type	Gas	Type of Body	SUV
Colour	White

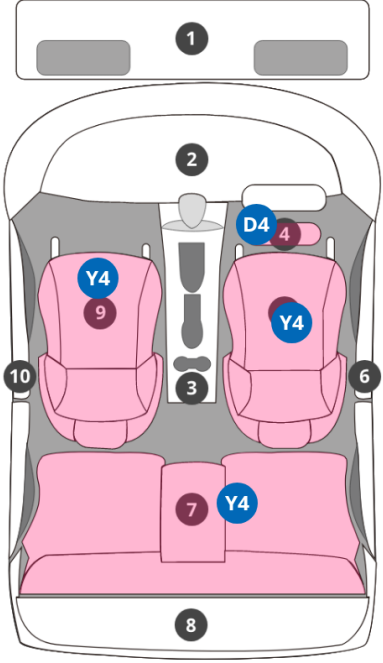
Interior Evaluation : C	Exterior Evaluation : C

<p>a : Cut, Fray d : Loose, Deformed k : Animal Hair s : Smell t : Cigarette Burns x : Defective y : Stain</p>

<p>A : Scratch AU : Scratch & Dent B : Modified C : Corrosion G : Stone chip P : Faded S : Rust SC : Rust & Corrosion U : Dent X : Defective Y : Crack, Gap</p>
<p>Remarks Rear Seat - Grime - Large / (R) Front Seat - Grime - Large / (L) Front Seat - Grime - Large / (L) Front Floor Mat - Worked - Large</p>	<p>Remarks Front Bumper, Grille, Lamps - Scratch - Medium / (R) Front Fender, Molding - Scratch - Medium / (R) Rear Fender, Molding - Scratch - Medium / (R) Front Door, Molding - Scratch - Large / Bonnet, Headlight - Dent - Small / (R) Rear Door, Molding - Crack, Gap - Small / Rear Bumper, Lamps, Panels - Scratch - Small / (L) Rear Fender, Molding - Scratch - Minimal / (L) Rear Door, Molding - Scratch - Minimal / (L) Front Door, Molding - Scratch - Minimal / (L) Front Fender, Molding - Scratch - Minimal</p>
