General Information

Make	Toyota	Model	Vios
YOM	2024	Odo Meter Reading	26,194
Registration No.	FAR9447	Chassis No.	PA1B18F31R4259385
CC	1.3	Transmission	CVT
Fuel Type	Gas	Type of Body	Sedan
Colour	Red Mica Metallic

Body / Panel Condition

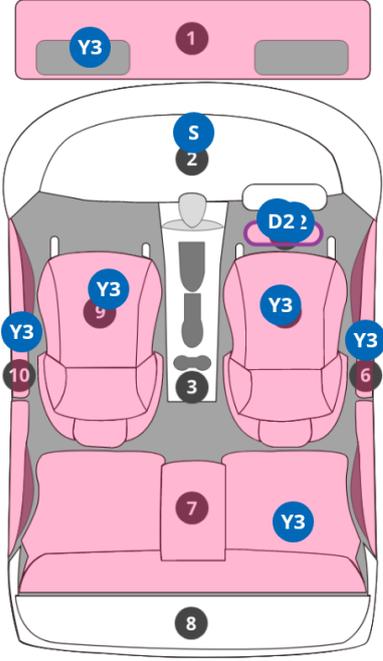
Interior Evaluation : C	Exterior Evaluation : E

<p>a : Cut, Fray d : Loose, Deformed k : Animal Hair s : Smell t : Cigarette Burns x : Defective y : Stain</p>

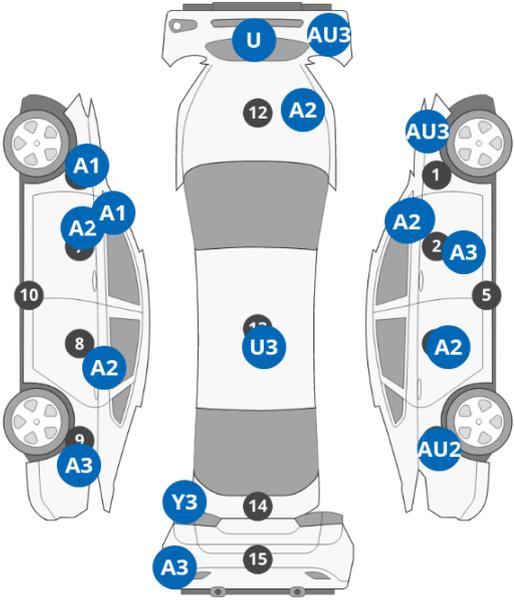
<p>A : Scratch AU : Scratch & Dent B : Modified C : Corrosion G : Stone chip P : Faded S : Rust SC : Rust & Corrosion U : Dent X : Defective Y : Crack, Gap</p>
<p>Remarks Overall Interior - Smell - Yes / (L) Front Seat - Grime - Medium / (R) Front Seat - Grime - Medium / (L) Front Trim - Grime - Medium / Rear Seat - Grime - Medium / (R) Front Trim - Grime - Medium / Mat Other - Worked - Small / (R) Front Floor Mat - Missing - Yes / (L) Front Floor Mat - Worked - Small / Ceiling - Grime - Medium</p>	<p>Remarks Member (Bolted) - Dent - Yes / (R) Front Fender, Molding - Scratch & Dent - Medium / (R) Mirror - Stuck - Yes / (R) Mirror - Scratch - Small / (R) Front Door, Molding - Scratch - Medium / (R) Rear Door, Molding - Scratch - Small / (R) Rear Fender, Molding - Scratch & Dent - Small / Trunk Hood, Rear Gate - Crack, Gap - Medium / Rear Bumper, Lamps, Panels - Scratch - Medium / (L) Rear Fender, Molding - Scratch - Medium / (L) Rear Door, Molding - Scratch - Small / Roof - Dent - Medium / (L) Front Door, Molding - Scratch - Small / (L) Mirror - Scratch - Minimal / (L) Front Fender, Molding - Scratch - Minimal / Front Bumper, Grille, Lamps - Scratch & Dent - Medium / Bonnet, Headlight - Scratch - Small</p>
