## General Information

| Make | Toyota | Model | Vios |
| Registration No. | FAS2107 | Chassis No. | PA1B18F30R4272354 |

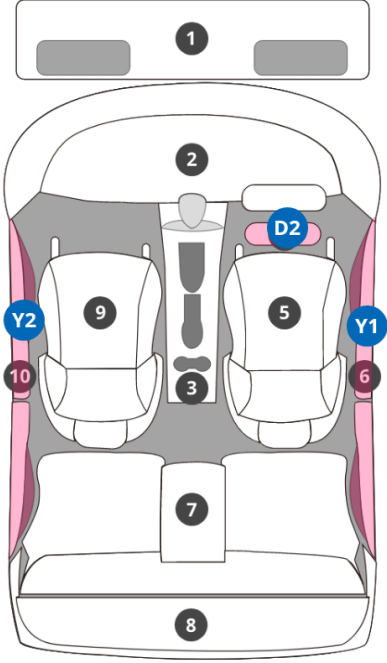
| Interior Evaluation : <b>A</b> | Exterior Evaluation : <b>E</b> |
|---|---|
| <p><b>Remarks</b><br/>(L) Front Trim - Grime - Small / (L) Front Floor Mat - Worked - Small / (R) Front Trim - Grime - Minimal</p> | <p><b>Remarks</b><br/>Bonnet, Headlight - Crack, Gap - Small / Front Bumper, Grille, Lamps - Scratch &amp; Dent - Large / Member (Bolted) - Dent - Yes / (L) Front Fender, Molding - Scratch &amp; Dent - Large / (L) Front Door, Molding - Scratch - Medium / Roof - Dent - Medium / Rear Bumper, Lamps, Panels - Scratch - Medium / Trunk Hood, Rear Gate - Scratch - Minimal / (R) Step, In-panel, Side Spoiler - Scratch &amp; Dent - Large / (L) Rear Door, Molding - Scratch &amp; Dent - Minimal / (L) Rear Fender, Molding - Scratch - Small / (R) Rear Fender, Molding - Scratch - Small / (R) Rear Door, Molding - Scratch - Medium / (R) Front Door, Molding - Dent - Small / (R) Front Fender, Molding - Scratch - Small / (R) Mirror - Scratch - Minimal / (L) Mirror - Scratch - Minimal</p> |
