## General Information

| Make | Toyota | Model | Avanza |

## Body / Panel Condition

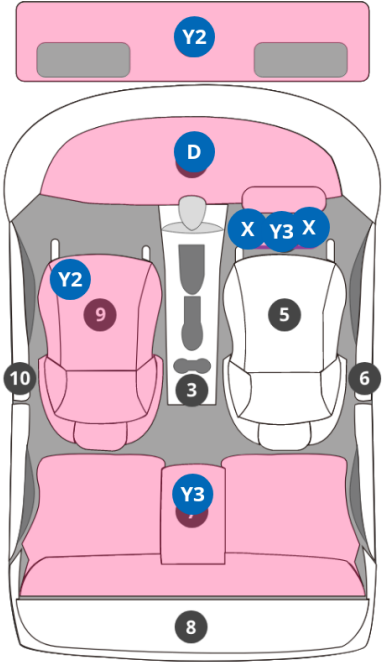
| Interior Evaluation : <b>B</b> | Exterior Evaluation : <b>C</b> |
| <b>Remarks</b><br>Ceiling - Grime - Small / (R) Front Floor Mat - Missing - Yes / Dashboard - Traces of Adhesive Tape - Yes / Rear Seat - Grime - Medium / (L) Front Seat - Grime - Small / (L) Front Floor Mat - Missing - Yes / Mat Other - Grime - Medium | <b>Remarks</b><br>(R) Front Fender, Molding - Scratch & Dent - Small / (R) Rear Fender, Molding - Scratch & Dent - Small / (R) Front Door, Molding - Scratch - Small / (R) Rear Door, Molding - Scratch - Small / Rear Bumper, Lamps, Panels - Scratch - Small / (L) Rear Fender, Molding - Dent - Small / (L) Mirror - Scratch - Minimal / (L) Front Door, Molding - Scratch - Small / (L) Front Fender, Molding - Scratch & Dent - Small / Front Bumper, Grille, Lamps - Scratch & Dent - Medium |
