General Information

Make	Toyota	Model	Vios
YOM	2025	Odo Meter Reading	9,332
Registration No.	FAS8232	Chassis No.	PA1B18F36S4283221
CC	1.3	Transmission	CVT
Fuel Type	Gas	Type of Body	Sedan
Colour	Black

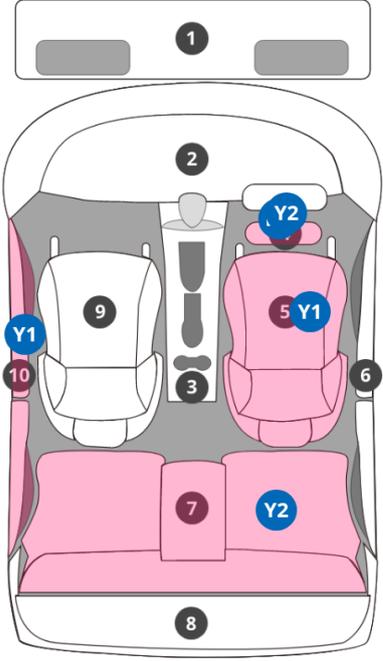
Interior Evaluation : A	Exterior Evaluation : B

<p>a : Cut, Fray d : Loose, Deformed k : Animal Hair s : Smell t : Cigarette Burns x : Defective y : Stain</p>

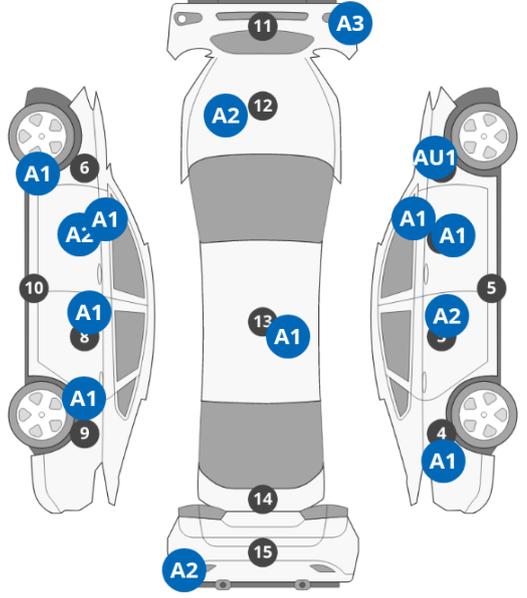
<p>A : Scratch AU : Scratch & Dent B : Modified C : Corrosion G : Stone chip P : Faded S : Rust SC : Rust & Corrosion U : Dent X : Defective Y : Crack, Gap</p>
<p>Remarks (L) Front Floor Mat - Worked - Small / (R) Front Floor Mat - Grime - Small / Rear Seat - Grime - Small / (R) Front Seat - Grime - Minimal / (L) Front Trim - Grime - Minimal</p>	<p>Remarks (R) Front Fender, Molding - Scratch & Dent - Minimal / (R) Front Door, Molding - Scratch - Minimal / (R) Rear Door, Molding - Scratch - Small / (R) Mirror - Scratch - Minimal / (R) Rear Fender, Molding - Scratch - Minimal / Rear Bumper, Lamps, Panels - Scratch - Small / (L) Rear Fender, Molding - Scratch - Minimal / (L) Rear Door, Molding - Scratch - Minimal / (L) Front Door, Molding - Scratch - Small / (L) Mirror - Scratch - Minimal / (L) Front Fender, Molding - Scratch - Minimal / Front Bumper, Grille, Lamps - Scratch - Medium / Bonnet, Headlight - Scratch - Small / Roof - Scratch - Minimal</p>
