General Information

Make	Toyota	Model	Vios
YOM	2024	Odo Meter Reading	8,401
Registration No.	GBC3221	Chassis No.	PA1B18F39P4235476
CC	1.3	Transmission	CVT
Fuel Type	Gas	Type of Body	Sedan
Colour	Red Mica Metallic

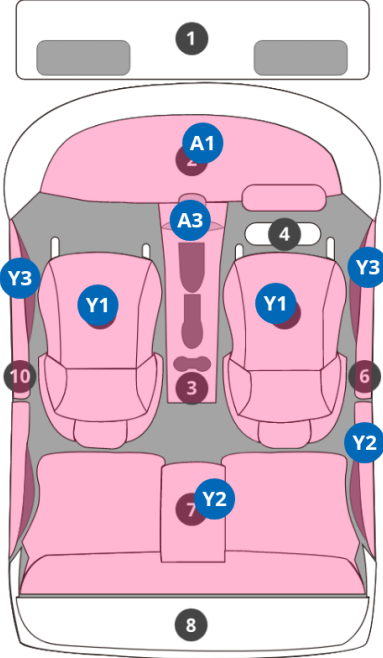
Interior Evaluation : B	Exterior Evaluation : C

<p>a : Cut, Fray d : Loose, Deformed k : Animal Hair s : Smell t : Cigarette Burns x : Defective y : Stain</p>

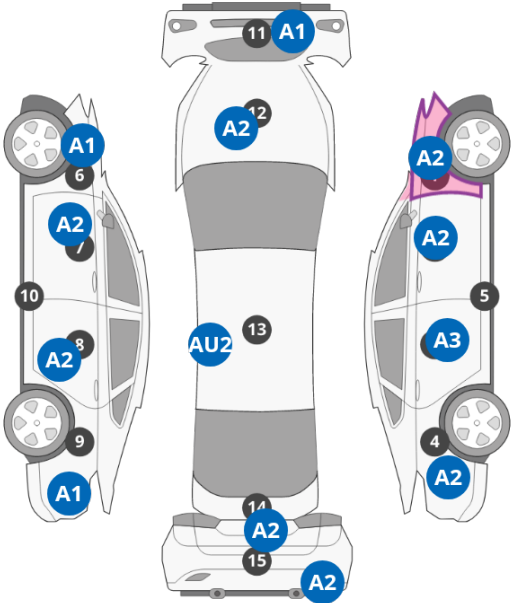
<p>A : Scratch AU : Scratch & Dent B : Modified C : Corrosion G : Stone chip P : Faded S : Rust SC : Rust & Corrosion U : Dent X : Defective Y : Crack, Gap</p>
<p>Remarks Rear Seat - Grime - Small / (L) Front Trim - Grime - Medium / (R) Front Seat - Grime - Minimal / (L) Front Seat - Grime - Minimal / (R) Rear Trim - Grime - Small / (R) Front Trim - Grime - Medium / Console, Switches, Vents - Worn, Scratch, Cut, Crack - Medium / Dashboard - Worn, Scratch, Cut, Crack - Minimal</p>	<p>Remarks (R) Front Fender - Repair Traces - Yes / (R) Front Fender, Molding - Repair mark - Yes / Roof - Scratch & Dent - Small / (L) Rear Door, Molding - Scratch - Small / (L) Rear Fender, Molding - Scratch - Minimal / (L) Front Door, Molding - Scratch - Small / (L) Front Fender, Molding - Scratch - Minimal / (R) Front Fender, Molding - Scratch - Small / Bonnet, Headlight - Scratch - Small / (R) Rear Door, Molding - Scratch - Medium / (R) Front Door, Molding - Scratch - Small / Trunk Hood, Rear Gate - Scratch - Small / Rear Bumper, Lamps, Panels - Scratch - Small / (R) Rear Fender, Molding - Scratch - Small / Front Bumper, Grille, Lamps - Scratch - Minimal</p>
