General Information

Make	Toyota	Model	Vios
YOM	2024	Odo Meter Reading	5,548
Registration No.	GBE3909	Chassis No.	PA1B18F34R4253693
CC	1.3	Transmission	CVT
Fuel Type	Gas	Type of Body	Sedan
Colour	Red

Body / Panel Condition

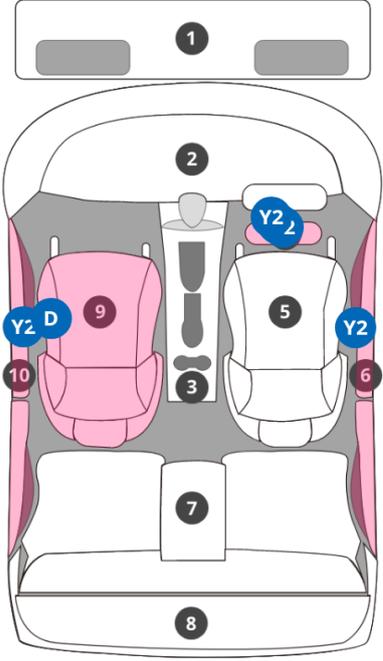
Interior Evaluation : B	Exterior Evaluation : C

<p>a : Cut, Fray d : Loose, Deformed k : Animal Hair s : Smell t : Cigarette Burns x : Defective y : Stain</p>

<p>A : Scratch AU : Scratch & Dent B : Modified C : Corrosion G : Stone chip P : Faded S : Rust SC : Rust & Corrosion U : Dent X : Defective Y : Crack, Gap</p>
<p>Remarks (R) Front Trim - Grime - Small / (L) Front Trim - Grime - Small / (L) Front Floor Mat - Worked - Small / (R) Front Floor Mat - Grime - Small / (L) Front Seat - Worn - Yes / Mat Other - Grime - Small</p>	<p>Remarks (R) Front Fender, Molding - Scratch & Dent - Small / (R) Mirror - Scratch - Minimal / (R) Front Door, Molding - Scratch - Small / (R) Rear Door, Molding - Scratch & Dent - Medium / (R) Rear Fender, Molding - Scratch & Dent - Small / Rear Bumper, Lamps, Panels - Scratch & Dent - Medium / (L) Rear Fender, Molding - Scratch - Minimal / (L) Step, In-panel, Side Spoiler - Scratch - Medium / (L) Rear Door, Molding - Scratch - Minimal / (L) Front Door, Molding - Scratch - Minimal / (L) Mirror - Scratch - Minimal / (L) Front Fender, Molding - Scratch - Minimal / Front Bumper, Grille, Lamps - Scratch - Medium / Bonnet, Headlight - Scratch - Minimal / Roof - Scratch - Minimal / Trunk Hood, Rear Gate - Scratch - Minimal</p>

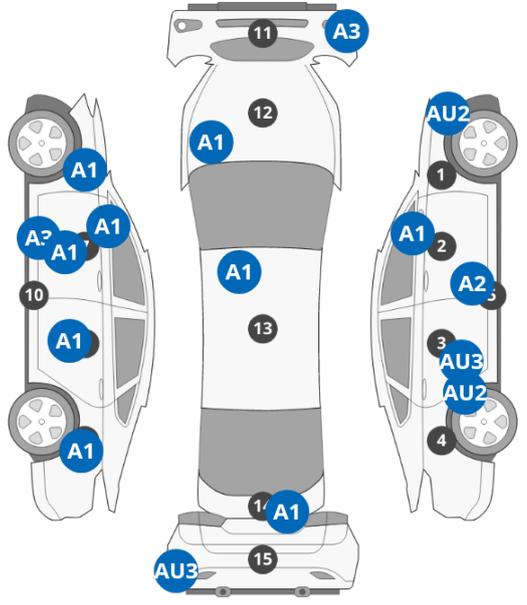
<p>Inspector Notes</p>
<p>with warranty booklet, with jack and tools, with spare tire, no LTO plate, scratches on tail light</p>
