General Information

Make	Toyota	Model	Vios
YOM	2020	Odo Meter Reading	30,041
Registration No.	GAO4685	Chassis No.	PA1B18F30L4110330
CC	1.3	Transmission	M/T
Fuel Type	Gas	Type of Body	Sedan
Colour	Green

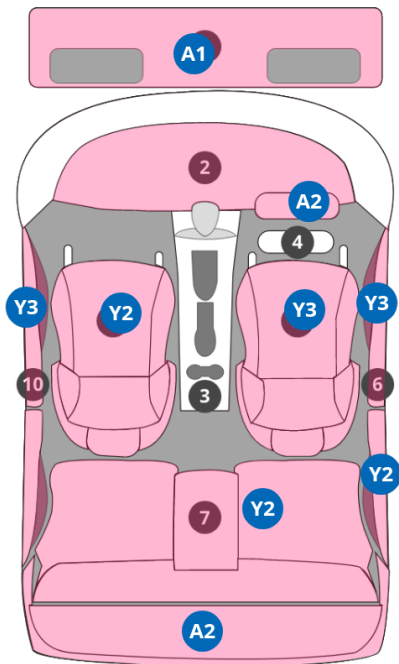
Interior Evaluation : C	Exterior Evaluation : D

<p>a : Cut, Fray d : Loose, Deformed k : Animal Hair s : Smell t : Cigarette Burns x : Defective y : Stain</p>

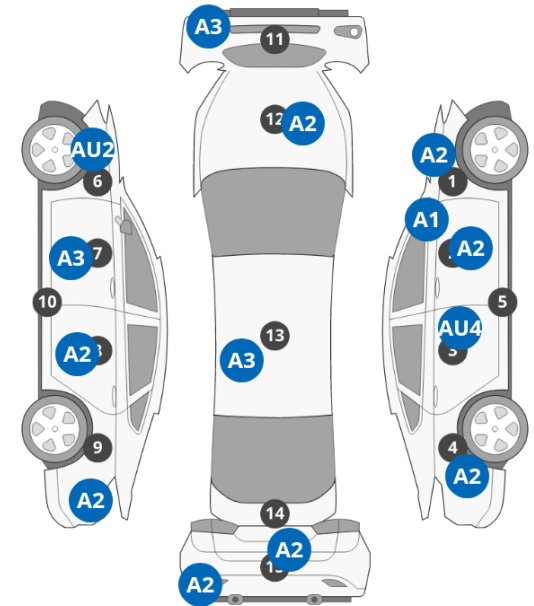
<p>A : Scratch AU : Scratch & Dent B : Modified C : Corrosion G : Stone chip P : Faded S : Rust SC : Rust & Corrosion U : Dent X : Defective Y : Crack, Gap</p>
<p>Remarks Trunk Room - Worn, Scratch, Cut, Crack - Small / Rear Seat - Grime - Small / (R) Front Seat - Grime - Medium / (R) Front Trim - Grime - Medium / (R) Rear Trim - Grime - Small / (L) Front Seat - Grime - Small / Steering Wheel - Worn, Peel, Crack - Small / (L) Front Trim - Grime - Medium / Ceiling - Cut, Crack - Minimal</p>	<p>Remarks (R) Rear Door - Repair Traces - Yes / (L) Front Fender, Molding - Scratch & Dent - Small / Bonnet, Headlight - Scratch - Small / Front Bumper, Grille, Lamps - Scratch - Medium / (R) Mirror - Scratch - Minimal / (R) Front Door, Molding - Scratch - Small / (R) Front Fender, Molding - Scratch - Small / (R) Rear Door, Molding - Scratch & Dent - Large / (R) Rear Fender, Molding - Scratch - Small / Trunk Hood, Rear Gate - Scratch - Small / Rear Bumper, Lamps, Panels - Scratch - Small / (L) Rear Fender, Molding - Scratch - Small / (L) Rear Door, Molding - Scratch - Small / (L) Front Door, Molding - Scratch - Medium / Roof - Scratch - Medium</p>
