General Information

| Make | Toyota | Model | Rush |
| Registration No. | GBF8538 | Chassis No. | MHKE8FF3PRK062907 |

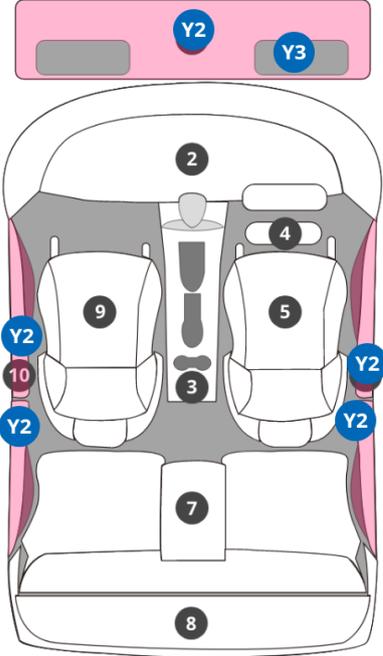
| Interior Evaluation : B | Exterior Evaluation : D |
| <p>Remarks Ceiling - Grime - Small / (R) Front Trim - Grime - Small / (R) Rear Trim - Grime - Small / (L) Rear Trim - Grime - Small / (L) Front Trim - Grime - Small / Sunvisor, Sunglass Holder - Grime - Medium</p> | <p>Remarks (R) Front Fender, Molding - Scratch - Small / (R) Mirror - Scratch - Minimal / (R) Front Door, Molding - Scratch - Small / (R) Rear Door, Molding - Scratch - Small / (R) Rear Fender, Molding - Scratch - Medium / Trunk Hood, Rear Gate - Scratch - Small / Rear Bumper, Lamps, Panels - Scratch - Medium / (L) Rear Fender, Molding - Scratch - Small / (L) Rear Door, Molding - Scratch - Small / (L) Mirror - Scratch - Minimal / (L) Front Door, Molding - Scratch - Minimal / (L) Front Fender, Molding - Scratch - Small / Front Bumper, Grille, Lamps - Scratch & Dent - Medium / Bonnet, Headlight - Scratch - Medium</p> |
