## General Information

<b>Make</b>	Toyota	<b>Model</b>	Vios
<b>YOM</b>	2021	<b>Odo Meter Reading</b>	59,434
<b>Registration No.</b>	KAG6381 - Non Moving	<b>Chassis No.</b>	PA1B18F34M4149066
<b>CC</b>	1.3	<b>Transmission</b>	M/T
<b>Fuel Type</b>	Gas	<b>Type of Body</b>	Sedan
<b>Colour</b>	Red

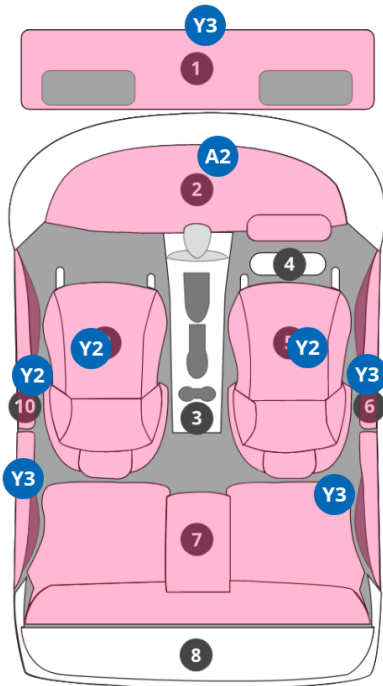
<b>Interior Evaluation :</b> <span style="float: right; color: red; font-weight: bold;">C</span>	<b>Exterior Evaluation :</b> <span style="float: right; color: red; font-weight: bold;">C</span>

<p><b>a</b> : Cut, Fray <b>d</b> : Loose, Deformed <b>k</b> : Animal Hair <b>s</b> : Smell <b>t</b> : Cigarette Burns <b>x</b> : Defective <b>y</b> : Stain</p>

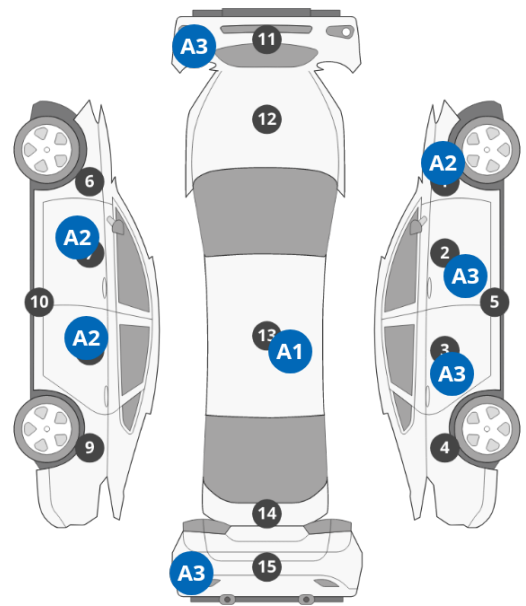
<p><b>A</b> : Scratch <b>AU</b> : Scratch &amp; Dent <b>B</b> : Modified <b>C</b> : Corrosion <b>G</b> : Stone chip <b>P</b> : Faded <b>S</b> : Rust <b>SC</b> : Rust &amp; Corrosion <b>U</b> : Dent <b>X</b> : Defective <b>Y</b> : Crack, Gap</p>
<p><b>Remarks</b> Rear Seat - Grime - Medium / Ceiling - Grime - Medium / (R) Front Trim - Grime - Medium / (L) Front Seat - Grime - Small / (R) Front Seat - Grime - Small / Dashboard - Worn, Scratch, Cut, Crack - Small / (L) Front Trim - Grime - Small / (L) Rear Trim - Grime - Medium</p>	<p><b>Remarks</b> (R) Front Door - Repair Traces - Yes / Bonnet - Repair Traces - Yes / (R) Front Fender, Molding - Scratch - Small / (R) Front Door, Molding - Scratch - Medium / (R) Rear Door, Molding - Scratch - Medium / Rear Bumper, Lamps, Panels - Scratch - Medium / (L) Front Door, Molding - Scratch - Small / (L) Rear Door, Molding - Scratch - Small / Front Bumper, Grille, Lamps - Scratch - Medium / Roof - Scratch - Minimal</p>
