## General Information

| Make | Toyota | Model | Vios |
| YOM | 2024 | Odo Meter Reading | 8,833 |

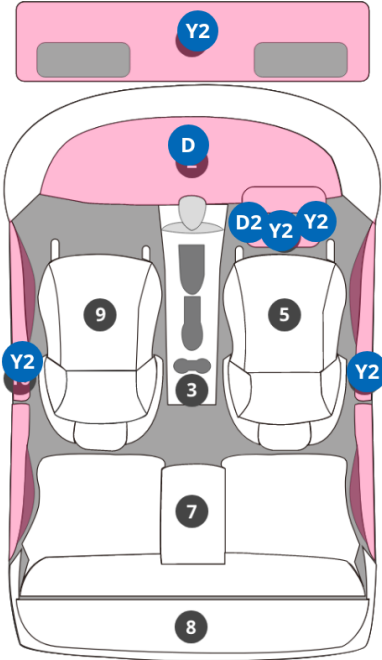
| Interior Evaluation : | B | Exterior Evaluation : | D |
|---|---|---|---|
| <b>Remarks</b><br>Ceiling - Grime - Small / (R) Front Trim - Grime - Small / (R) Front Floor Mat - Grime - Small / Dashboard - Traces of Adhesive Tape - Yes / Mat Other - Grime - Small / (L) Front Trim - Grime - Small / (L) Front Floor Mat - Worked - Small | | <b>Remarks</b><br>(R) Mirror - Scratch - Small / (R) Rear Door, Molding - Scratch & Dent - Large / (R) Front Door, Molding - Scratch - Medium / (R) Rear Fender, Molding - Scratch - Small / Rear Bumper, Lamps, Panels - Scratch - Small / Trunk Hood, Rear Gate - Scratch - Small / (L) Rear Door, Molding - Scratch - Small / (L) Rear Fender, Molding - Scratch - Minimal / (L) Mirror - Scratch - Small / (L) Front Door, Molding - Scratch - Small / (L) Front Fender, Molding - Scratch - Small / Bonnet, Headlight - Scratch - Medium / Front Bumper, Grille, Lamps - Scratch - Small / (R) Front Fender, Molding - Scratch - Small | |
