General Information

Make	Toyota	Model	Vios
YOM	2024	Odo Meter Reading	21,734
Registration No.	BE336A	Chassis No.	PA1B18F33P4237286
CC	1.3	Transmission	CVT
Fuel Type	Gas	Type of Body	Sedan
Colour	Black

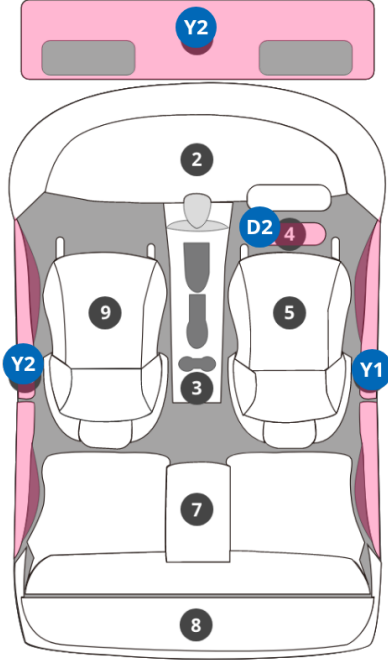
Interior Evaluation : A	Exterior Evaluation : E

<p>a : Cut, Fray d : Loose, Deformed k : Animal Hair s : Smell t : Cigarette Burns x : Defective y : Stain</p>

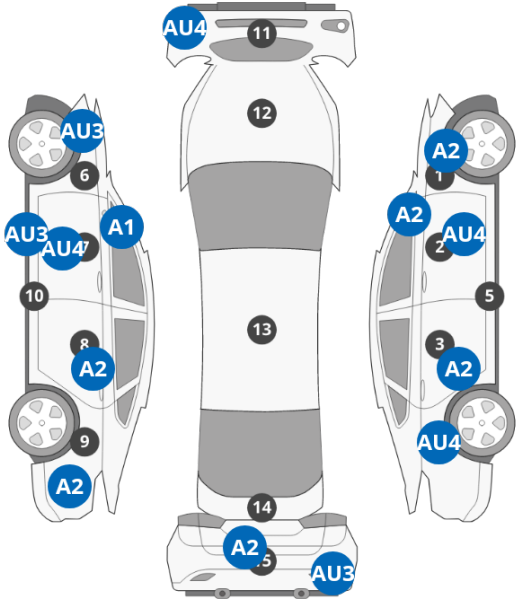
<p>A : Scratch AU : Scratch & Dent B : Modified C : Corrosion G : Stone chip P : Faded S : Rust SC : Rust & Corrosion U : Dent X : Defective Y : Crack, Gap</p>
<p>Remarks (R) Front Trim - Grime - Minimal / (L) Front Trim - Grime - Small / (L) Front Floor Mat - Worked - Small / Ceiling - Grime - Small</p>	<p>Remarks (R) Front Fender, Molding - Scratch - Small / (R) Front Door, Molding - Scratch & Dent - Large / (R) Mirror - Scratch - Small / (R) Rear Door, Molding - Scratch - Small / (R) Rear Fender, Molding - Scratch & Dent - Large / Rear Bumper, Lamps, Panels - Scratch & Dent - Medium / Trunk Hood, Rear Gate - Scratch - Small / (L) Rear Fender, Molding - Scratch - Small / (L) Rear Door, Molding - Scratch - Small / (L) Front Door, Molding - Scratch & Dent - Large / (L) Step, In-panel, Side Spoiler - Scratch & Dent - Medium / (L) Front Fender, Molding - Scratch & Dent - Medium / Front Bumper, Grille, Lamps - Scratch & Dent - Large / (L) Mirror - Scratch - Minimal</p>
