General Information

Make	Toyota	Model	Vios
YOM	2024	Odo Meter Reading	28,911
Registration No.	DBO8480	Chassis No.	PA1B18F31R4258172
CC	1.3	Transmission	CVT
Fuel Type	Gas	Type of Body	Sedan
Colour	Black

Body / Panel Condition

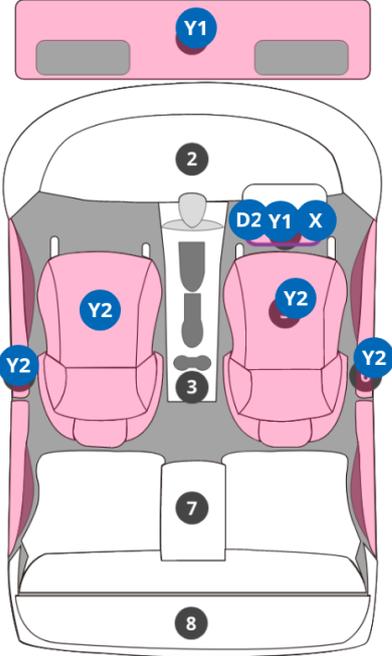
Interior Evaluation : B	Exterior Evaluation : E

<p>a : Cut, Fray d : Loose, Deformed k : Animal Hair s : Smell t : Cigarette Burns x : Defective y : Stain</p>

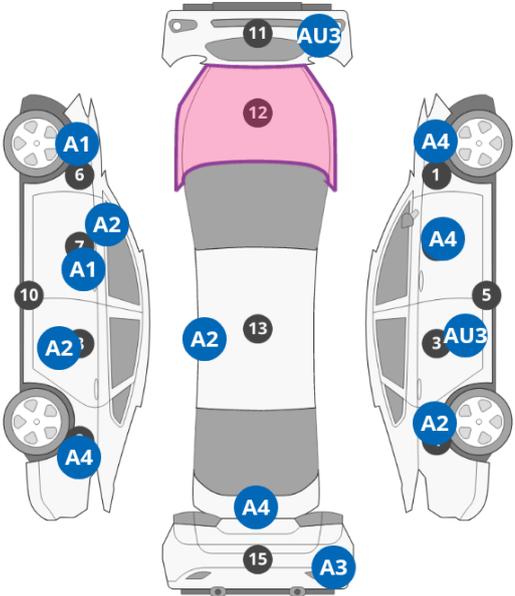
<p>A : Scratch AU : Scratch & Dent B : Modified C : Corrosion G : Stone chip P : Faded S : Rust SC : Rust & Corrosion U : Dent X : Defective Y : Crack, Gap</p>
<p>Remarks (L) Front Seat - Grime - Small / (L) Front Floor Mat - Worked - Small / (L) Front Trim - Grime - Small / Ceiling - Grime - Minimal / Mat Other - Grime - Minimal / (R) Front Trim - Grime - Small / (R) Front Seat - Grime - Small / (R) Front Floor Mat - Missing - Yes</p>	<p>Remarks Bonnet - Repair Traces - Yes / (L) Rear Fender - Repair Traces - Yes / (L) Rear Fender, Molding - Scratch - Large / (L) Rear Door, Molding - Scratch - Small / (L) Front Door, Molding - Scratch - Minimal / (L) Mirror - Scratch - Small / (L) Front Fender, Molding - Scratch - Minimal / Bonnet, Headlight - Repair mark - Yes / (R) Front Fender, Molding - Scratch - Large / (R) Front Door, Molding - Scratch - Large / (R) Rear Door, Molding - Scratch & Dent - Medium / (R) Rear Fender, Molding - Scratch - Small / Trunk Hood, Rear Gate - Scratch - Large / Rear Bumper, Lamps, Panels - Scratch - Medium / Roof - Scratch - Small / Front Bumper, Grille, Lamps - Scratch & Dent - Medium</p>

<p>Inspector Notes</p>
<p>Missing foglamps. Crack left headlight and right taillight. Trunk floor missing. Front Toyota emblem mssing. Toe hook cover missing. Without warranty booklet,spare tire,jack,tools and seat cover. 1 key. With LTO plate.</p>
