General Information

Make	Toyota	Model	Vios
YOM	2022	Odo Meter Reading	42,091
Registration No.	GAW7390	Chassis No.	PA1B18F34N4172154
CC	1.3	Transmission	CVT
Fuel Type	Gas	Type of Body	Sedan
Colour	Blue

Body / Panel Condition

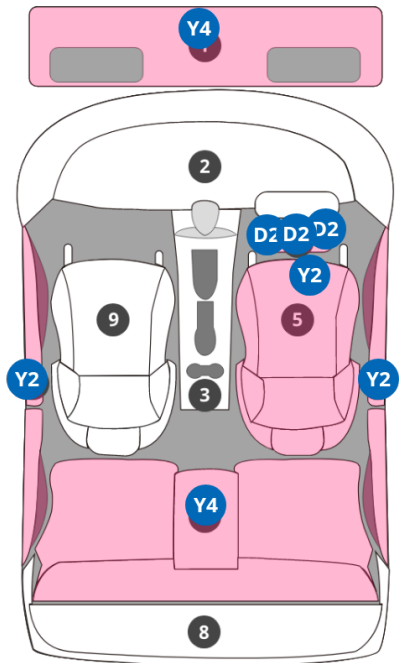
Interior Evaluation : C	Exterior Evaluation : E

<p>a : Cut, Fray d : Loose, Deformed k : Animal Hair s : Smell t : Cigarette Burns x : Defective y : Stain</p>

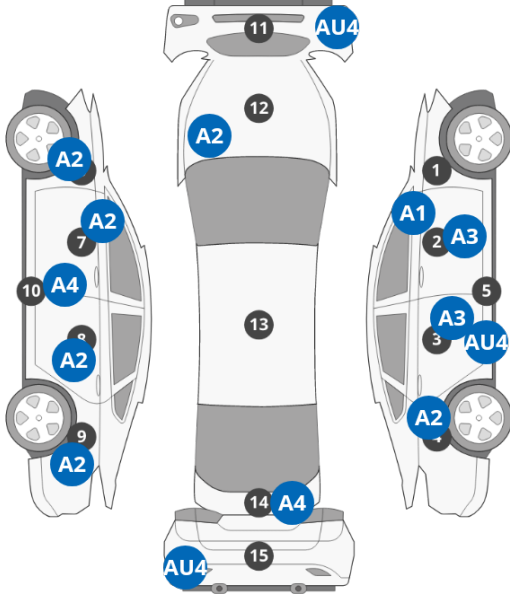
<p>A : Scratch AU : Scratch & Dent B : Modified C : Corrosion G : Stone chip P : Faded S : Rust SC : Rust & Corrosion U : Dent X : Defective Y : Crack, Gap</p>
<p>Remarks (R) Front Trim - Grime - Small / (R) Front Seat - Grime - Small / Ceiling - Grime - Large / Rear Seat - Grime - Large / (L) Front Trim - Grime - Small / (L) Front Floor Mat - Worked - Small / (R) Front Floor Mat - Worked - Small / Mat Other - Worked - Small</p>	<p>Remarks Rear Bumper, Lamps, Panels - Scratch & Dent - Large / (L) Rear Fender, Molding - Scratch - Small / (L) Front Door, Molding - Scratch - Large / (L) Rear Door, Molding - Scratch - Small / (L) Mirror - Scratch - Small / (L) Front Fender, Molding - Scratch - Small / Trunk Hood, Rear Gate - Scratch - Large / (R) Rear Fender, Molding - Scratch - Small / (R) Step, In-panel, Side Spoiler - Scratch & Dent - Large / (R) Rear Door, Molding - Scratch - Medium / (R) Front Door, Molding - Scratch - Medium / (R) Mirror - Scratch - Minimal / Front Bumper, Grille, Lamps - Scratch & Dent - Large / Bonnet, Headlight - Scratch - Small</p>
