## General Information

| <b>Make</b> | Suzuki | <b>Model</b> | XL7 |

## Body / Panel Condition

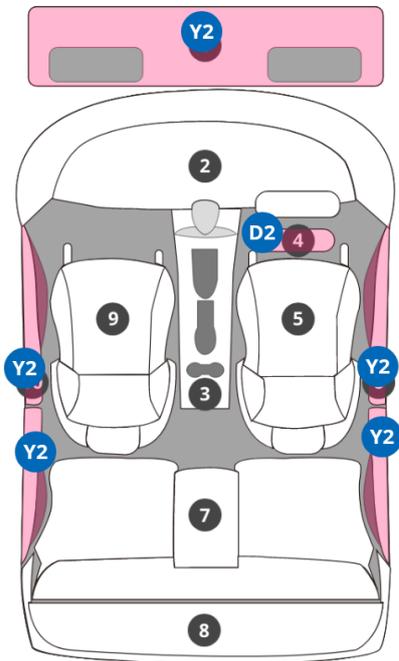
| <b>Interior Evaluation :</b> <span style="float: right;"><b>B</b></span> | <b>Exterior Evaluation :</b> <span style="float: right;"><b>A</b></span> |

| <p><b>Remarks</b><br/>(L) Front Floor Mat - Worked - Small / (L) Front Trim - Grime - Small / Ceiling - Grime - Small / (L) Rear Trim - Grime - Small / (R) Rear Trim - Grime - Small / (R) Front Trim - Grime - Small</p> | <p><b>Remarks</b><br/>(R) Front Door - Repair Traces - Yes / (R) Rear Door - Repair Traces - Yes / (L) Mirror - Scratch - Minimal / (L) Front Door, Molding - Scratch - Minimal / (L) Rear Fender, Molding - Scratch - Minimal / (L) Rear Door, Molding - Scratch - Minimal / Rear Bumper, Lamps, Panels - Scratch - Minimal / (R) Step, In-panel, Side Spoiler - Scratch - Minimal / Front Bumper, Grille, Lamps - Scratch - Small</p> |
