General Information

Make	Toyota	Model	Vios
YOM	2024	Odo Meter Reading	5,346
Registration No.	GBC8127	Chassis No.	PA1B18F31R4246023
CC	1.3	Transmission	CVT
Fuel Type	Gas	Type of Body	Sedan
Colour	Blue

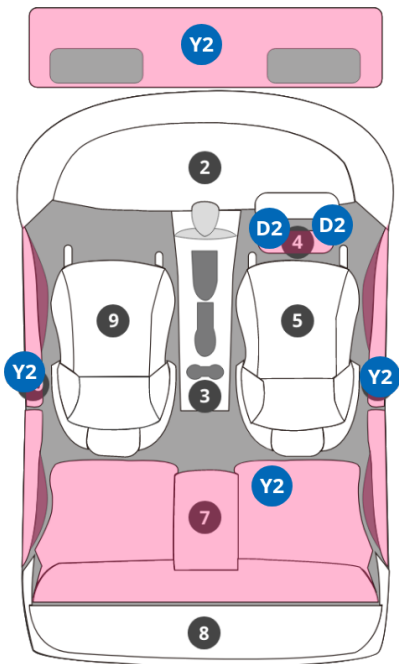
Interior Evaluation : B	Exterior Evaluation : E

<p>a : Cut, Fray d : Loose, Deformed k : Animal Hair s : Smell t : Cigarette Burns x : Defective y : Stain</p>

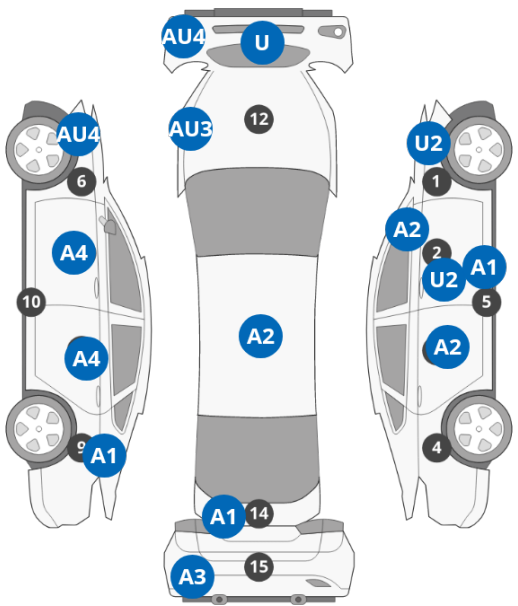
<p>A : Scratch AU : Scratch & Dent B : Modified C : Corrosion G : Stone chip P : Faded S : Rust SC : Rust & Corrosion U : Dent X : Defective Y : Crack, Gap</p>
<p>Remarks Ceiling - Grime - Small / (R) Front Trim - Grime - Small / (L) Front Trim - Grime - Small / Rear Seat - Grime - Small / (L) Front Floor Mat - Worked - Small / (R) Front Floor Mat - Worked - Small</p>	<p>Remarks Front Bumper, Grille, Lamps - Scratch & Dent - Large / (L) Front Fender, Molding - Scratch & Dent - Large / Bonnet, Headlight - Scratch & Dent - Medium / (R) Front Fender, Molding - Dent - Small / (R) Mirror - Scratch - Small / (R) Rear Door, Molding - Scratch - Small / (R) Front Door, Molding - Dent - Small / (R) Step, In-panel, Side Spoiler - Scratch - Minimal / Rear Bumper, Lamps, Panels - Scratch - Medium / (L) Rear Door, Molding - Scratch - Large / (L) Rear Fender, Molding - Scratch - Minimal / (L) Front Door, Molding - Scratch - Large / Roof - Scratch - Small / Trunk Hood, Rear Gate - Scratch - Minimal / Member (Bolted) - Dent - Yes</p>

Frame Evaluation : B	Functional Evaluation : C
<p>Remarks Left Front Inside Panel (Front Side) - Traces of Bending, or Marks of Panel Repair ? - Yes</p>	<p>Remarks Power Steering - Issue - Yes / Battery - Weak - Yes / Spare Key - Issue - Unexist</p>

<p>Inspector Notes</p>
<p>Damaged front left bumper, front left fender and bonnet. Crack headlight. Low Battery. With warranty booklet, spare tire and leather seat cover. Without jack and tools. 1 key. No LTO plate.</p>
