## General Information

| Make | Toyota | Model | Vios |
| Registration No. | GBD4747 | Chassis No. | PA1B18F3XR4256405 |

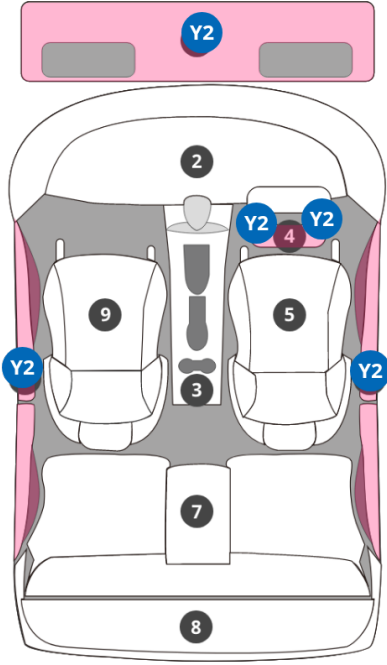
| Interior Evaluation : <b>B</b> | Exterior Evaluation : <b>C</b> |
|---|---|
| <b>Remarks</b><br>(R) Front Trim - Grime - Small / (R) Front Floor Mat - Grime - Small / (L) Front Trim - Grime - Small / (L) Front Floor Mat - Grime - Small / Ceiling - Grime - Small | <b>Remarks</b><br>(L) Mirror - Scratch - Minimal / (L) Front Door, Molding - Scratch - Small / (L) Rear Fender, Molding - Scratch - Minimal / (R) Rear Fender, Molding - Scratch - Large / Rear Bumper, Lamps, Panels - Scratch - Small / Trunk Hood, Rear Gate - Scratch - Small / (R) Rear Door, Molding - Scratch - Large / (R) Front Door, Molding - Scratch - Small / (R) Mirror - Scratch - Small / (R) Front Fender, Molding - Scratch - Minimal / Front Bumper, Grille, Lamps - Scratch - Small / Bonnet, Headlight - Scratch - Minimal |
