General Information

Make	Suzuki	Model	XL7
YOM	2024	Odo Meter Reading	15,290
Registration No.	GBE8207	Chassis No.	MHYNC32S5RJ103902
CC	1.5	Transmission	A/T
Fuel Type	Gas	Type of Body	Wagon
Colour	Gray

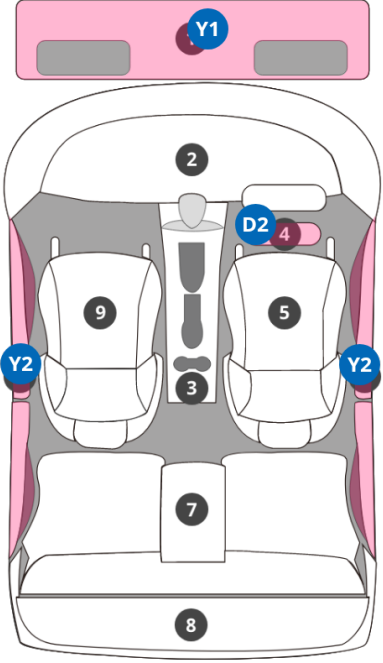
Interior Evaluation : A	Exterior Evaluation : D

<p>a : Cut, Fray d : Loose, Deformed k : Animal Hair s : Smell t : Cigarette Burns x : Defective y : Stain</p>

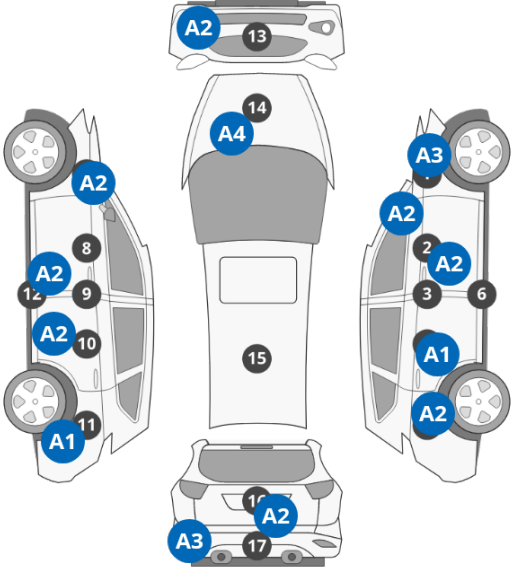
<p>A : Scratch AU : Scratch & Dent B : Modified C : Corrosion G : Stone chip P : Faded S : Rust SC : Rust & Corrosion U : Dent X : Defective Y : Crack, Gap</p>
<p>Remarks (R) Front Trim - Grime - Small / Ceiling - Grime - Minimal / (L) Front Trim - Grime - Small / (L) Front Floor Mat - Worked - Small</p>	<p>Remarks (R) Front Door, Molding - Scratch - Small / (R) Mirror - Scratch - Small / (R) Rear Door, Molding - Scratch - Minimal / (R) Rear Fender, Molding - Scratch - Small / Rear Bumper, Lamps, Panels - Scratch - Medium / Trunk Hood, Rear Gate - Scratch - Small / (L) Rear Door, Molding - Scratch - Small / (L) Rear Fender, Molding - Scratch - Minimal / (L) Front Door, Molding - Scratch - Small / (L) Front Fender, Molding - Scratch - Small / Bonnet, Headlight - Scratch - Large / (R) Front Fender, Molding - Scratch - Medium / Front Bumper, Grille, Lamps - Scratch - Small</p>
