General Information

Make	Toyota	Model	Innova
YOM	2024	Odo Meter Reading	3,467
Registration No.	GBE8750	Chassis No.	PA2JA8EM2R0143234
CC	2.8	Transmission	A/T
Fuel Type	Diesel	Type of Body	Wagon
Colour	Black

Body / Panel Condition

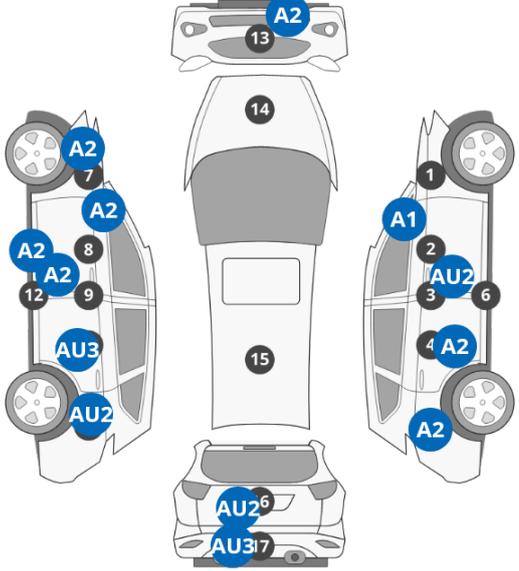
<p>A : Scratch AU : Scratch & Dent B : Modified C : Corrosion G : Stone chip P : Faded S : Rust SC : Rust & Corrosion U : Dent X : Defective Y : Crack, Gap</p>
<p>Remarks Ceiling - Grime - Minimal / (R) Front Trim - Grime - Small / (R) Front Floor Mat - Grime - Small / Mat Other - Grime - Small / (L) Front Trim - Grime - Small / (L) Front Floor Mat - Grime - Medium</p>	<p>Remarks Rear Bumper, Lamps, Panels - Scratch & Dent - Medium / Trunk Hood, Rear Gate - Scratch & Dent - Small / (L) Rear Fender, Molding - Scratch & Dent - Small / (L) Rear Door, Molding - Scratch & Dent - Medium / (L) Step, In-panel, Side Spoiler - Scratch - Small / (L) Front Door, Molding - Scratch - Small / (L) Mirror - Scratch - Small / (L) Front Fender, Molding - Scratch - Small / Front Bumper, Grille, Lamps - Scratch - Small / (R) Mirror - Scratch - Minimal / (R) Rear Door, Molding - Scratch - Small / (R) Rear Fender, Molding - Scratch - Small / (R) Front Door, Molding - Scratch & Dent - Small</p>
