General Information

Make	Toyota	Model	Lite Ace
YOM	2023	Odo Meter Reading	29,102
Registration No.	GBG2903	Chassis No.	MHKU3FE10NK002562
CC	1.5	Transmission	M/T
Fuel Type	Gas	Type of Body	Pickup
Colour	White

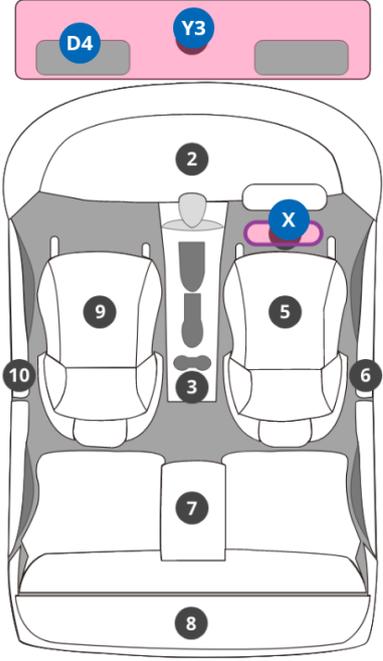
Interior Evaluation : C	Exterior Evaluation : D

<p>a : Cut, Fray d : Loose, Deformed k : Animal Hair s : Smell t : Cigarette Burns x : Defective y : Stain</p>

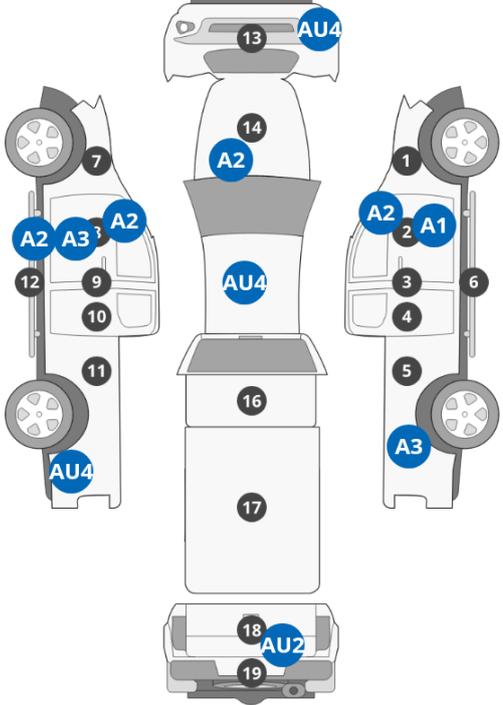
<p>A : Scratch AU : Scratch & Dent B : Modified C : Corrosion G : Stone chip P : Faded S : Rust SC : Rust & Corrosion U : Dent X : Defective Y : Crack, Gap</p>
<p>Remarks Ceiling - Grime - Medium / Sunvisor, Sunglass Holder - Loose, Deformed - Large / Mat Other - Missing - Yes</p>	<p>Remarks Front Bumper, Grille, Lamps - Scratch & Dent - Large / Bonnet, Headlight - Scratch - Small / (R) Mirror - Scratch - Small / (R) Front Door, Molding - Scratch - Minimal / (R) Side Gate - Scratch - Medium / Rear Gate - Scratch & Dent - Small / (L) Side Gate - Scratch & Dent - Large / (L) Front Door, Molding - Scratch - Medium / (L) Mirror - Scratch - Small / (L) Step, In-panel, Side Spoiler - Scratch - Small / Roof - Scratch & Dent - Large</p>
