## General Information

<b>Make</b>	Toyota	<b>Model</b>	Vios
<b>YOM</b>	2024	<b>Odo Meter Reading</b>	43,398
<b>Registration No.</b>	HAH3170	<b>Chassis No.</b>	PA1B18F30R4243971
<b>CC</b>	1.3	<b>Transmission</b>	CVT
<b>Fuel Type</b>	Gas	<b>Type of Body</b>	Sedan
<b>Colour</b>	Silver

## Body / Panel Condition

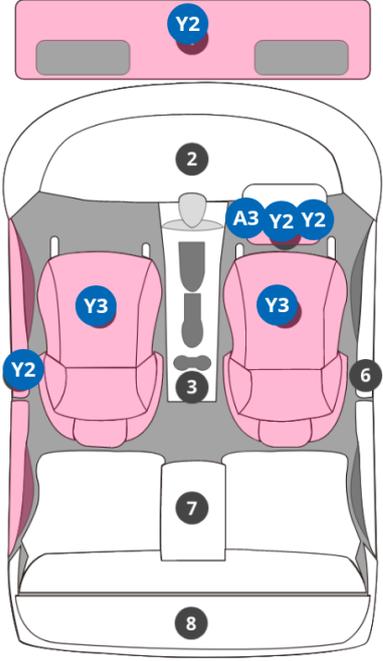
<b>Interior Evaluation :</b> <span style="color: red; font-weight: bold; font-size: 1.2em;">C</span>	<b>Exterior Evaluation :</b> <span style="color: red; font-weight: bold; font-size: 1.2em;">E</span>

<p><b>a</b> : Cut, Fray <b>d</b> : Loose, Deformed <b>k</b> : Animal Hair <b>s</b> : Smell <b>t</b> : Cigarette Burns <b>x</b> : Defective <b>y</b> : Stain</p>

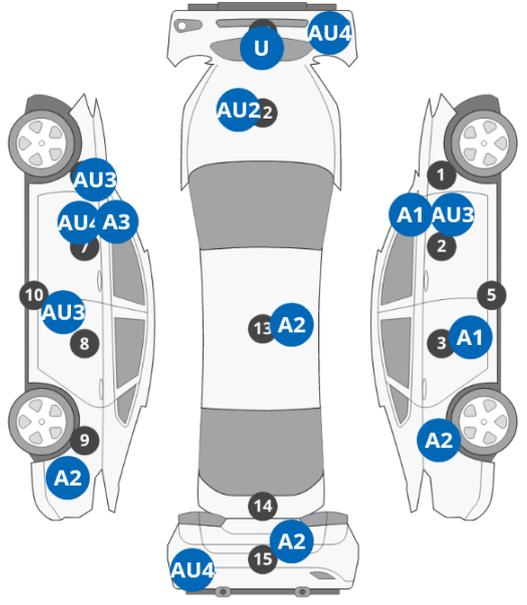
<p><b>A</b> : Scratch <b>AU</b> : Scratch &amp; Dent <b>B</b> : Modified <b>C</b> : Corrosion <b>G</b> : Stone chip <b>P</b> : Faded <b>S</b> : Rust <b>SC</b> : Rust &amp; Corrosion <b>U</b> : Dent <b>X</b> : Defective <b>Y</b> : Crack, Gap</p>
<p><b>Remarks</b>          Ceiling - Grime - Small / (R) Front Seat - Grime - Medium / (R) Front Floor Mat - Grime - Small / Mat Other - Grime - Small / (L) Front Trim - Grime - Small / (L) Front Floor Mat - Cut, Crack - Medium / (L) Front Seat - Grime - Medium</p>	<p><b>Remarks</b>          Member (Bolted) - Dent - Yes / Front Bumper, Grille, Lamps - Scratch &amp; Dent - Large / (R) Front Door, Molding - Scratch &amp; Dent - Medium / (R) Mirror - Scratch - Minimal / (R) Rear Door, Molding - Scratch - Minimal / (R) Rear Fender, Molding - Scratch - Small / Trunk Hood, Rear Gate - Scratch - Small / Rear Bumper, Lamps, Panels - Scratch &amp; Dent - Large / (L) Rear Fender, Molding - Scratch - Small / (L) Front Door, Molding - Scratch &amp; Dent - Large / (L) Rear Door, Molding - Scratch &amp; Dent - Medium / (L) Front Fender, Molding - Scratch &amp; Dent - Medium / (L) Mirror - Scratch - Medium / Bonnet, Headlight - Scratch &amp; Dent - Small / Roof - Scratch - Small</p>

<p><b>Inspector Notes</b></p>
<p>Damaged front bumper. Right front fender cover loose. Without warranty booklet, tools and seat cover. With spare tire and jack. 1 key. With LTO plate.</p>
