General Information

Make	Toyota	Model	Vios
YOM	2024	Odo Meter Reading	17,595
Registration No.	GBE1418	Chassis No.	PA1B18F36R4250956
CC	1.3	Transmission	CVT
Fuel Type	Gas	Type of Body	Sedan
Colour	Red Mica Metallic

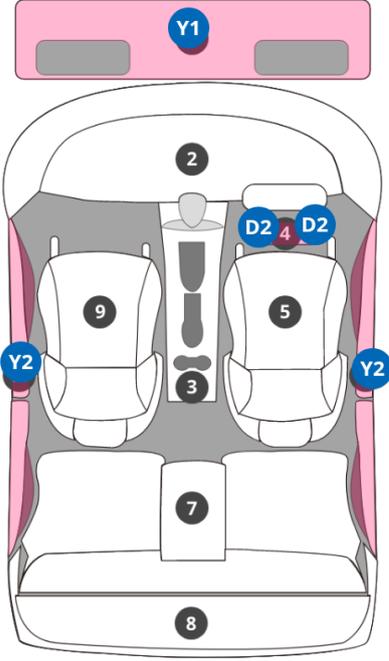
Interior Evaluation : B	Exterior Evaluation : D

<p>a : Cut, Fray d : Loose, Deformed k : Animal Hair s : Smell t : Cigarette Burns x : Defective y : Stain</p>

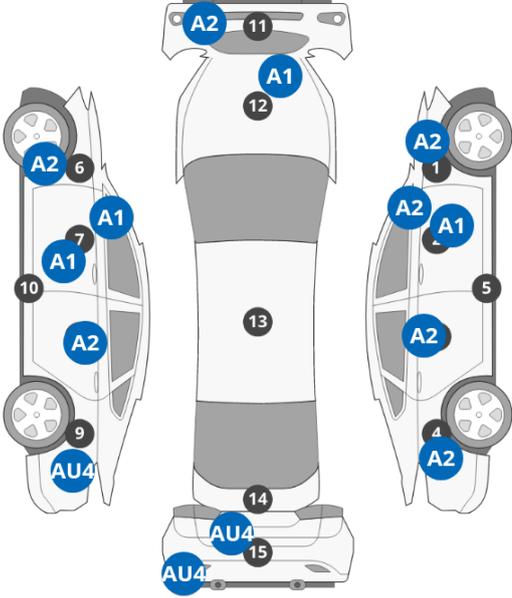
<p>A : Scratch AU : Scratch & Dent B : Modified C : Corrosion G : Stone chip P : Faded S : Rust SC : Rust & Corrosion U : Dent X : Defective Y : Crack, Gap</p>
Remarks (L) Front Floor Mat - Worked - Small / (L) Front Trim - Grime - Small / (R) Front Floor Mat - Worked - Small / (R) Front Trim - Grime - Small / Ceiling - Grime - Minimal	Remarks Trunk Hood, Rear Gate - Repair Traces - Yes / Rear End Panel - Repair Traces - Yes / (L) Rear Door, Molding - Scratch - Small / (L) Mirror - Scratch - Minimal / (L) Front Door, Molding - Scratch - Minimal / (L) Rear Fender, Molding - Scratch & Dent - Large / (L) Front Fender, Molding - Scratch - Small / Bonnet, Headlight - Scratch - Minimal / Front Bumper, Grille, Lamps - Scratch - Small / (R) Front Fender, Molding - Scratch - Small / (R) Mirror - Scratch - Small / (R) Front Door, Molding - Scratch - Minimal / (R) Rear Door, Molding - Scratch - Small / (R) Rear Fender, Molding - Scratch - Small / Trunk Hood, Rear Gate - Scratch & Dent - Large / Rear Bumper, Lamps, Panels - Scratch & Dent - Large

Inspector Notes
Rear bumper and trunk door damaged. Crack left taillight. Trunk floor missing. Without warranty booklet and tools. With spare tire,jack and seat cover. 3 keys. With LTO plate.
