General Information

Make	Toyota	Model	Avanza
YOM	2024	Odo Meter Reading	19,210
Registration No.	GBE5314	Chassis No.	MHFAA1BY8R0026230
CC	1.3	Transmission	CVT
Fuel Type	Gas	Type of Body	MPV
Colour	Silver

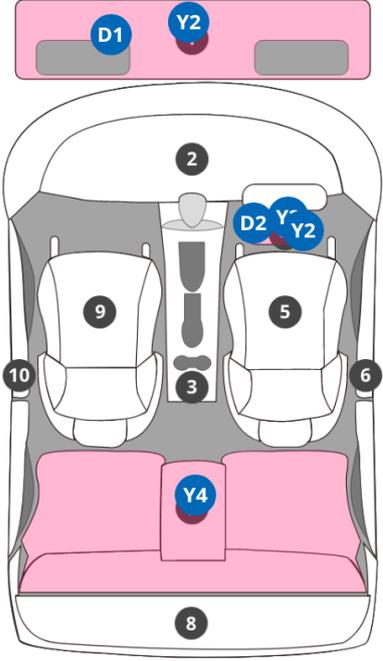
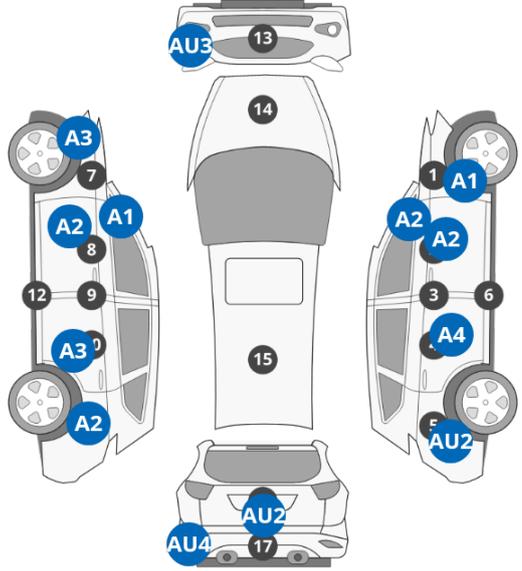
Interior Evaluation :	C	Exterior Evaluation :	E

<p>a : Cut, Fray d : Loose, Deformed k : Animal Hair s : Smell t : Cigarette Burns x : Defective y : Stain</p>		<p>A : Scratch AU : Scratch & Dent B : Modified C : Corrosion G : Stone chip P : Faded S : Rust SC : Rust & Corrosion U : Dent X : Defective Y : Crack, Gap</p>	
<p>Remarks Rear Seat - Grime - Large / Mat Other - Grime - Small / (L) Front Floor Mat - Worked - Small / (R) Front Floor Mat - Grime - Small / Ceiling - Grime - Small / Sunvisor, Sunglass Holder - Crinkle - Minimal</p>		<p>Remarks (R) Front Fender, Molding - Scratch - Minimal / (R) Mirror - Scratch - Small / (R) Front Door, Molding - Scratch - Small / (R) Rear Door, Molding - Scratch - Large / (R) Rear Fender, Molding - Scratch & Dent - Small / Rear Bumper, Lamps, Panels - Scratch & Dent - Large / Trunk Hood, Rear Gate - Scratch & Dent - Small / (L) Rear Fender, Molding - Scratch - Small / (L) Rear Door, Molding - Scratch - Medium / (L) Mirror - Scratch - Minimal / (L) Front Door, Molding - Scratch - Small / (L) Front Fender, Molding - Scratch - Medium / Front Bumper, Grille, Lamps - Scratch & Dent - Medium</p>
